**Town of Bon Accord**  
**AGENDA**  
**Regular Council Meeting**  
**October 5, 2021 7:00 p.m.**  
Virtual Meeting  
Live streamed on Bon Accord YouTube Channel

This report provides detailed information on low to high and immediate priority repairs or upgrades needed that could be incorporated into capital plans. This includes identifying any immediate safety or operational issues that must be addressed.

Associated Engineering Alberta Ltd. (AE) along with Solis Architecture Ltd. carried out a visual review and condition assessment of the Bon Accord Arena at 4812 52 Street in Bon Accord, Alberta on August 9, 2021. The Town of Bon Accord is considering renovating the Arena and wishes to obtain a summary of the condition of the facility and the budget required to perform the upgrades.

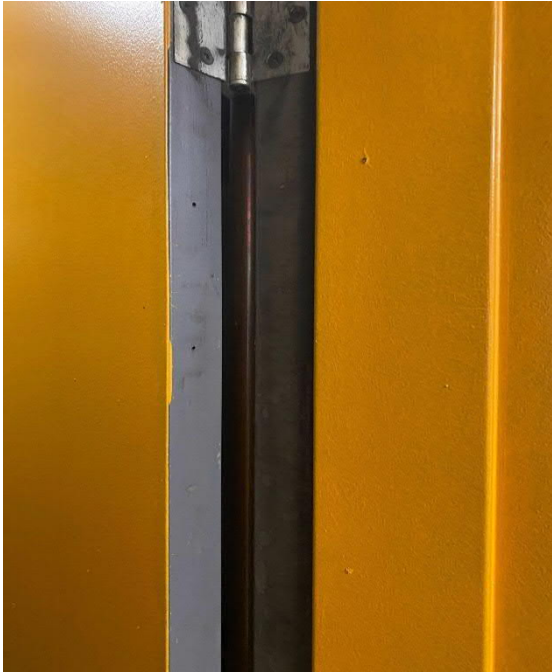
Fire rated doors have labels on the door and the frame indicating the fire rating. There are several doors that have the ratings removed from the door. It is important to note that once a label is removed, it can't be reattached by facility personnel. The assembly will have to go through the field labeling process described in NFPA 80. The ratings labels must be kept on the door and be visible.

Figure 2-1: Door into Mechanical Room - Rating Missing

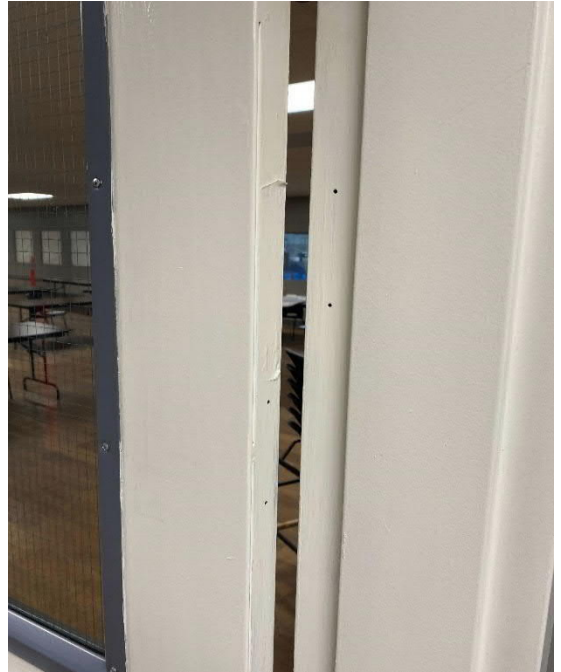
Figure 2-2: Door into Mezzanine from Elevator - Rating Missing

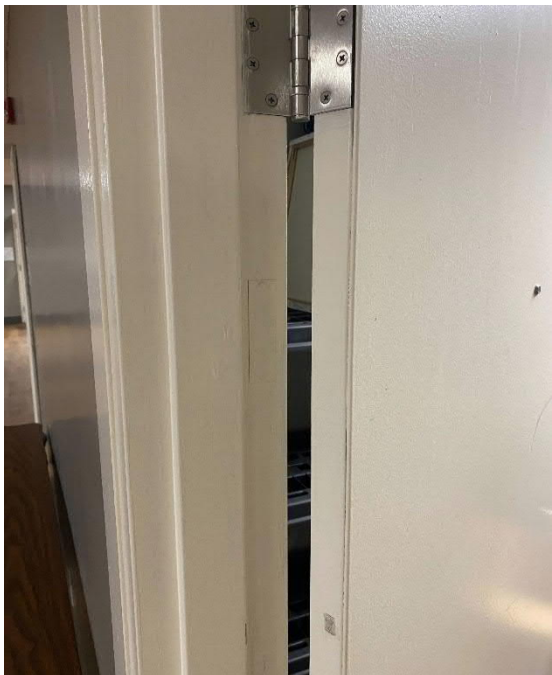
Figure 2-3: Door into Arena - East Side - Rating Covered

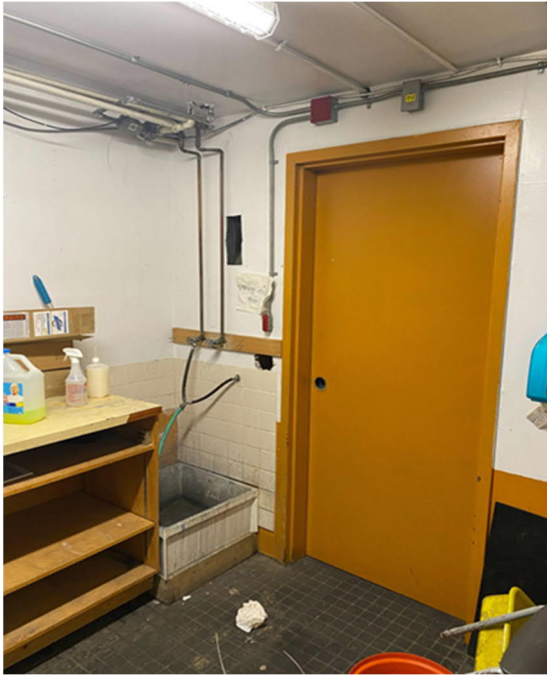
Figure 2-5: Mechanical Room Door - No Hardware Duct Penetration in Wall - No Damper

- Fire caulking required at the top of janitor's room, and service room walls.
- Replace existing bleachers with new as part of the renovation and address any fire rating required at that time.
- Patch and repair penetrations through rated wall assemblies.
- Repair hole on the south east corner of the wall between the Lobby and ice rink.
- Add fire damper at duct between the Janitor's Room and the Mechanical Room.
- Install fire ratings on doors as per NFPA 80.
- Install a new ice plant separated from the building and accessible from outside so the ice plant does not need to have costly renovations to meet the requirements of CSA B52. The existing ice plant space can be converted to storage.

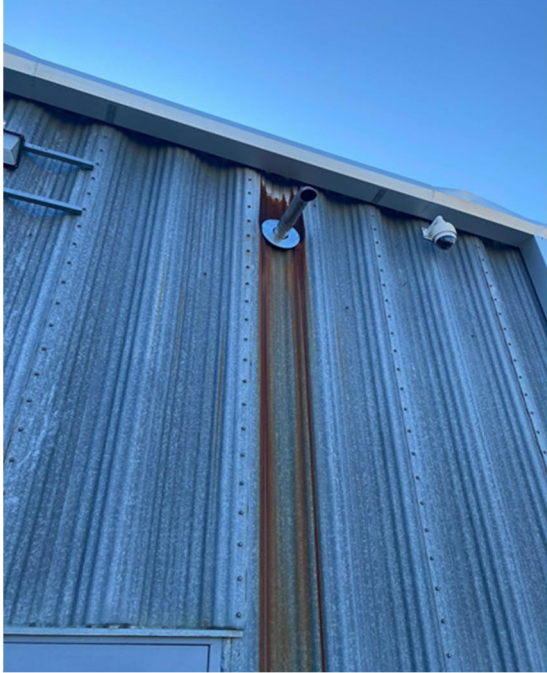
**Figure 2-13: Rusting & Water Staining under the Exhaust**

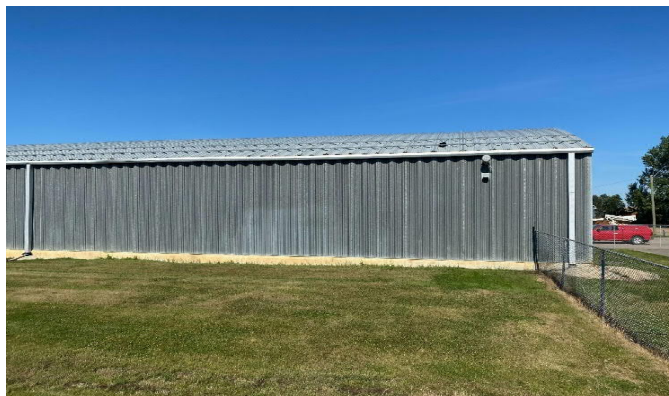
**Figure 2-17: South Side – Rusting at the End of the Panels**

In conjunction with the upgrades noted in the building envelope it is recommended that the insulation extend up over the roof and a new metal roof be installed over the insulation. This will provide a continuous air/vapour barrier on the warm side. The existing cellulose insulation should be removed, and the venting would be covered as it's not required with the relocation of the vapour barrier and insulation.

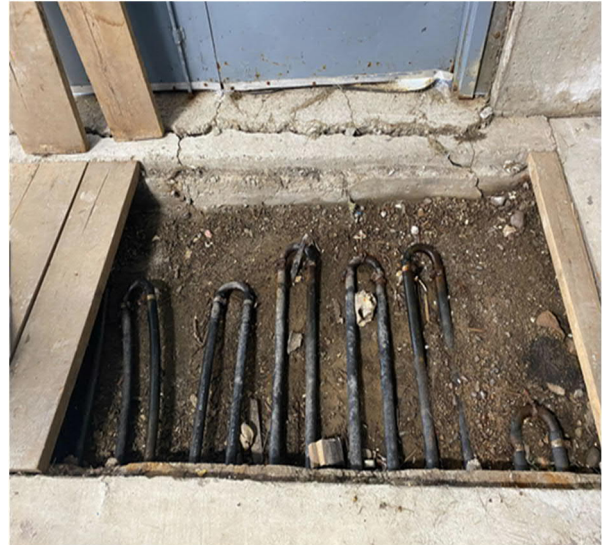
Figure 2-19: Ice Rink Tubes in Slab by Cracked Slab at Door

Due to the age of the rink, and the modification already completed to extend the lifespan of the slab, a new concrete slab is recommended. It is not recommended to try to extend the lifespan of the current system as the system has already been retrofitted once and the piping is beyond its lifespan. The installation of a new slab and ice plant is the optimal time to perform a deep energy retrofit for the overall building because a new ice plant can help with the overall heating and cooling of the building with high grade heat recovery and other energy efficiencies optimizing the entire heating and cooling system for the building.

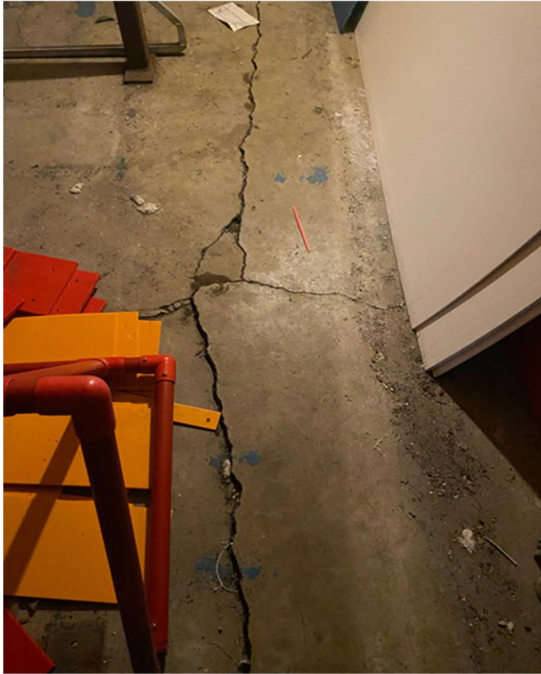
Figure 2-24: Crack in Slab on East Side of Rink under Bleachers

It is recommended that the warm slab be replaced at the same time as the rink slab. This would also remove the existing bleachers, which can be replaced or reinstated.

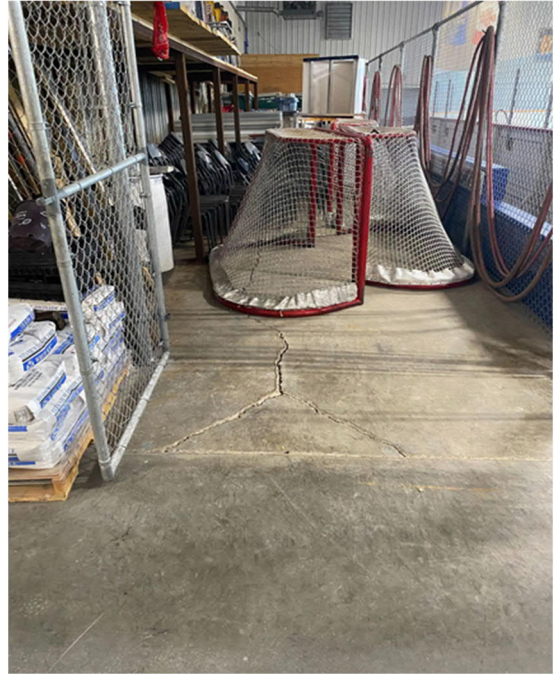
Figure 2-25: Crack in Slab on West Side of Rink

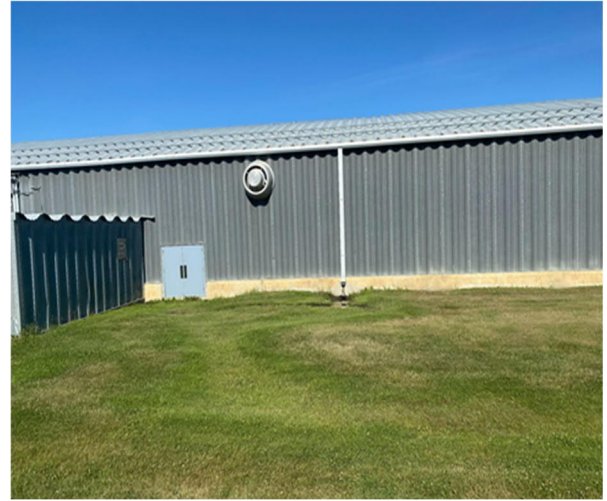
Figure 2-37: Revise Grading to Create a Swale on the East Side

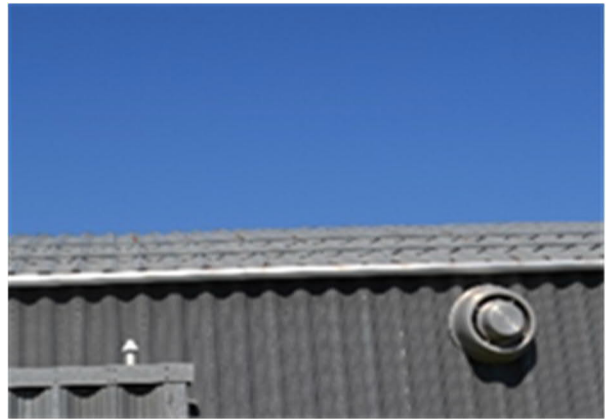
- Rusting on the exterior roof sheathing.
- Plates supporting the drain and ribbed sheathing together are severely rusted.
- Dirt and debris inside drains. To be cleaned.

Figure 3-8: Rusting on the Exterior Roof Sheathing

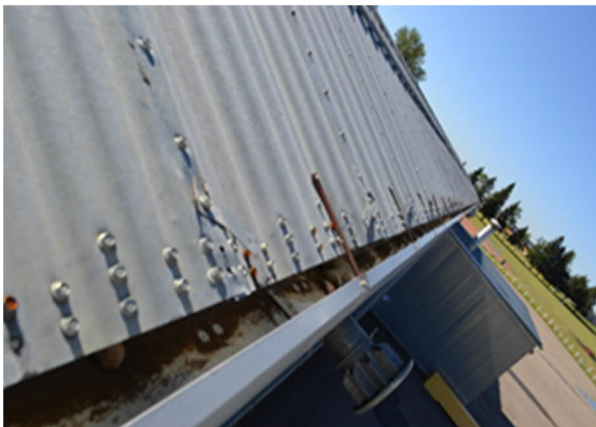
Figure 3-9: Dirt & Debris Inside Drains

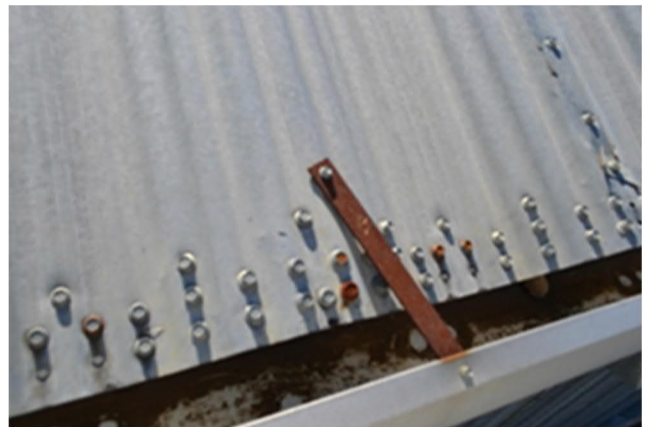
Figure 3-10: Rusted Supporting the Drain Plates

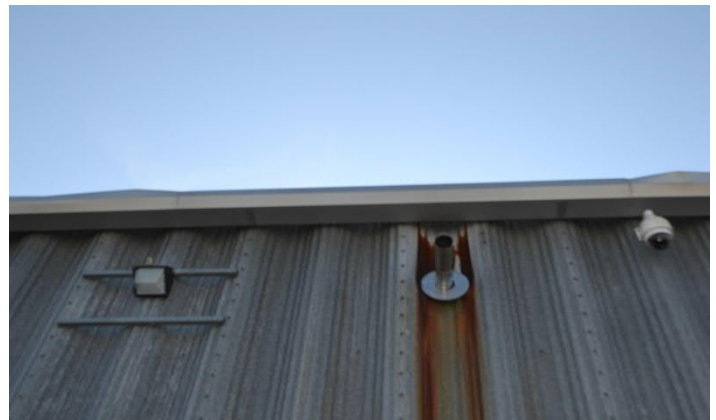
- Significant rusting at pipe penetrations on the north and south side of the building.
- Rusted corrugated sheathing between the concrete foundation under the bleachers.
- Damaged corrugated metal sheathing on the north side of the building.

Figure 3-12: Rusting at Pipe Penetrations

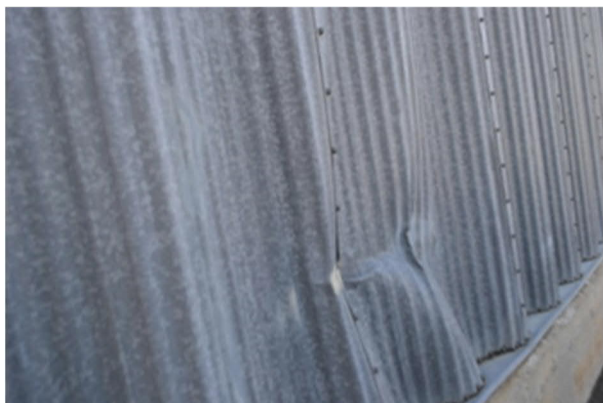
Figure 3-13: Damaged Corrugated Sheathing

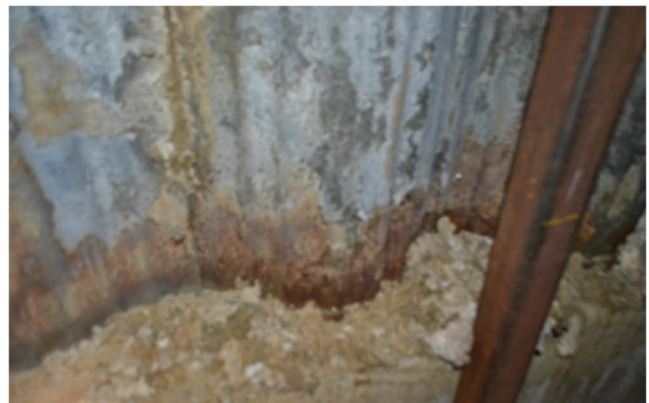
Figure 3-14: Rusted Corrugated Sheathing under Bleachers

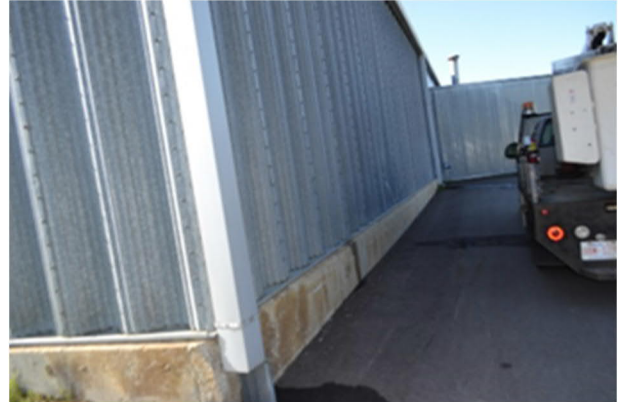
**Figure 3-16: Concrete Discolouration of Foundation Wall Typical**

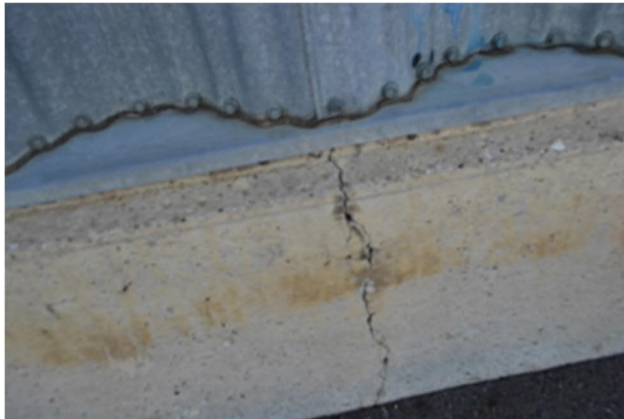
**Figure 3-17: Shrinkage Crack on Building Foundation Walls**

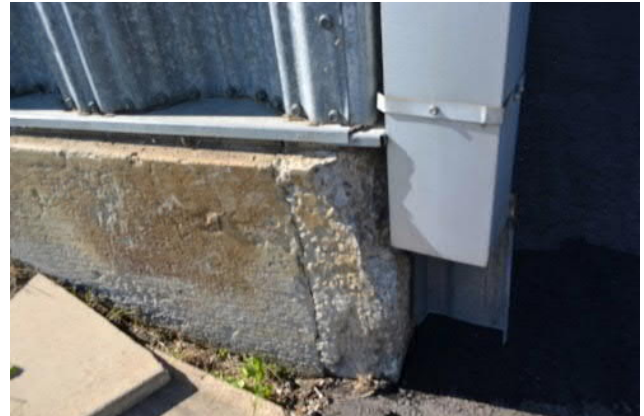
**Figure 3-18: Concrete Scaling at Door Location**

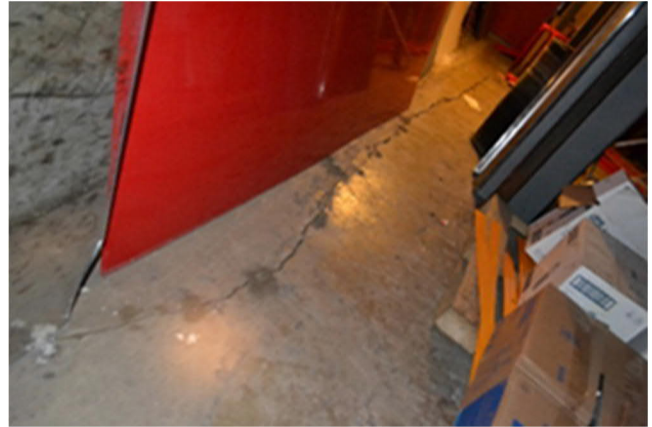
Figure 3-20: Cracked Slab under Bleachers

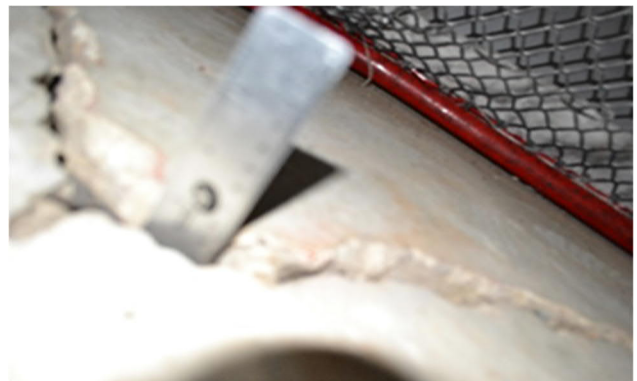
Figure 3-22: Cracked Slab at Storage Area at South East Corner of Arena

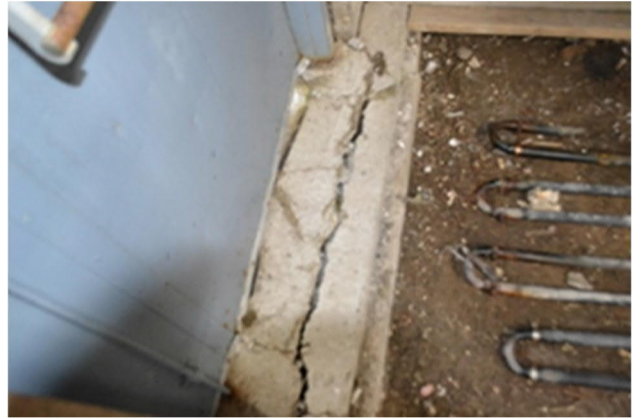
Figure 3-24: Severely Cracked Slab Thickening at Main Entrance

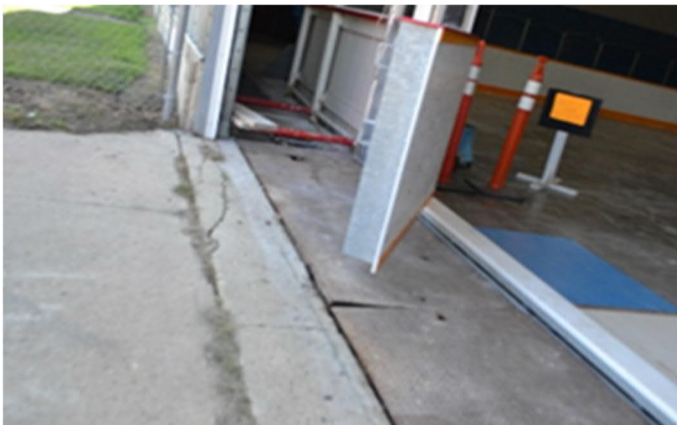
Figure 3-25: Damaged Concrete

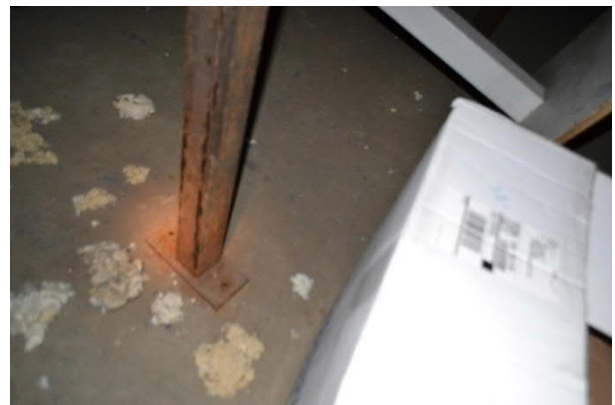
Figure 3-29: Base of Bleachers with Post & Baseplate Missing Bolts

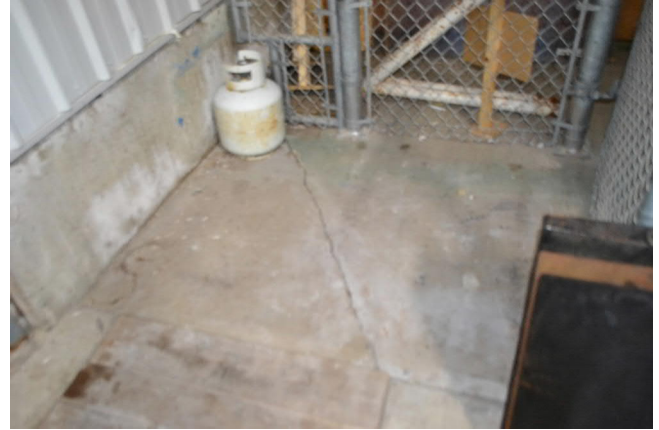
- Slab on grade is cracked. The cracks are approximately 0.7mm wide and vary in length.
- The concrete slab on grade and equipment housekeeping are discoloured.

Figure 3-31: Cracked Plant Room Floor Slab

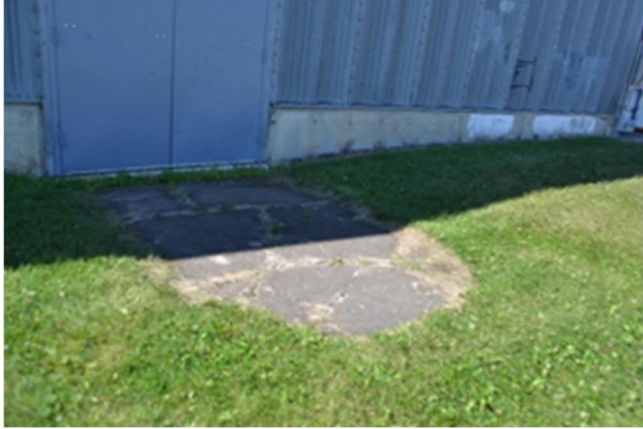
- Deteriorated exterior pad is on the north side of building is severely fragmented. There is likely no reinforcement in the concrete pad.
- Generally, there is organics growing between the perimeter foundation wall and exterior slabs.

Figure 3-37: Deteriorated Exit Slab  
on North Side of Building

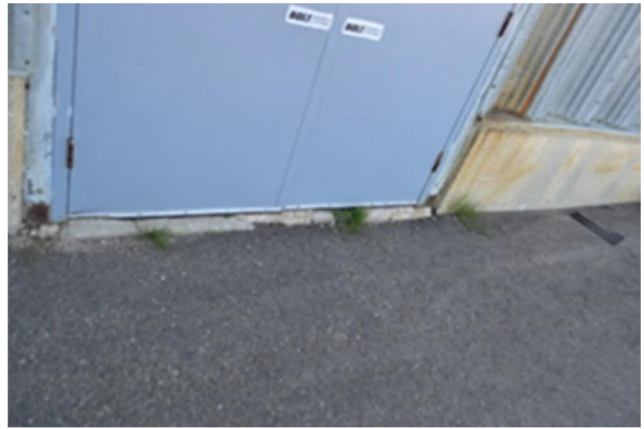
Figure 3-38: Organics Growing  
at Door Locations

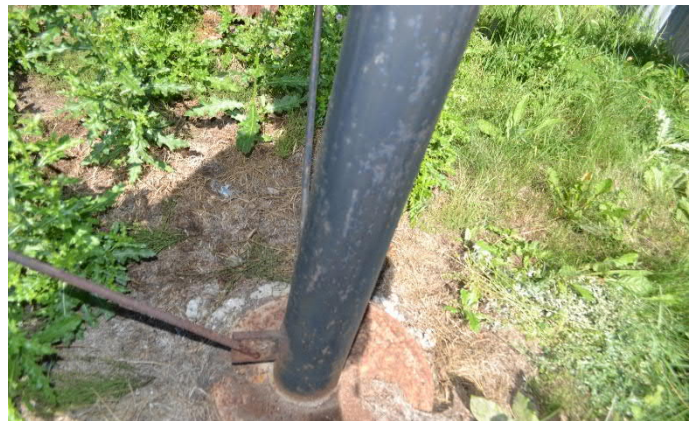
Figure 3-40: Rusty Base Plate

The steel should be wire brushed to determine the extent of the effects of the rust. If damage is significant then repairs should be undertaken.

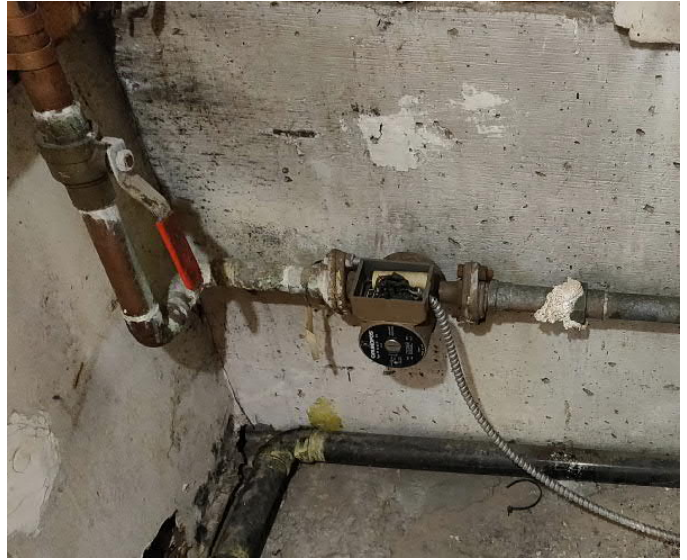
Figure 4-5: Significant Corrosion on Hot Water Piping

- Install backflow prevention to CSA B64 on the municipal water supply and make-up water for the ice plant.
- Replace the original sections of hot and cold copper plumbing piping and insulate the new piping.
- Investigate the cause of water marks on ceilings and repair plumbing piping as required.
- Replace damaged or missing pipe hangers throughout the facility.

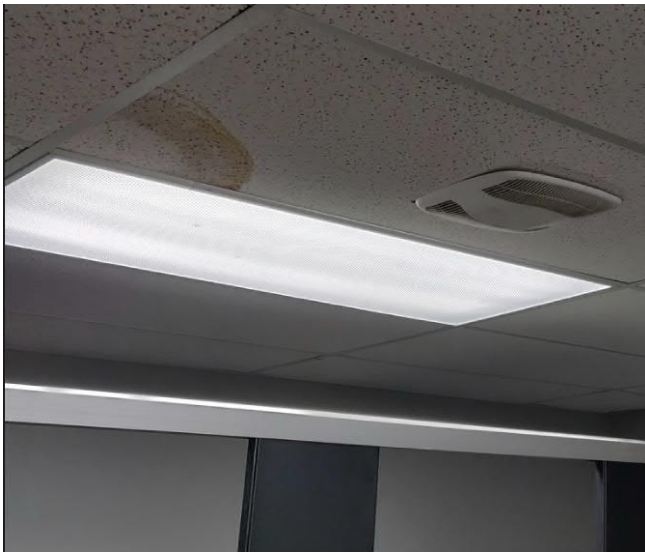
Figure 4-6: Ceiling Stain in 2<sup>nd</sup> Floor Washroom

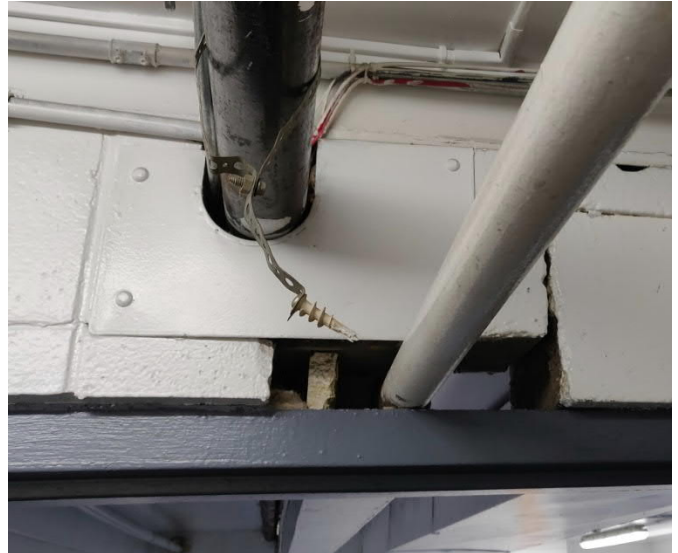
Figure 4-7: Damaged & Inadequate Pipe Hangers

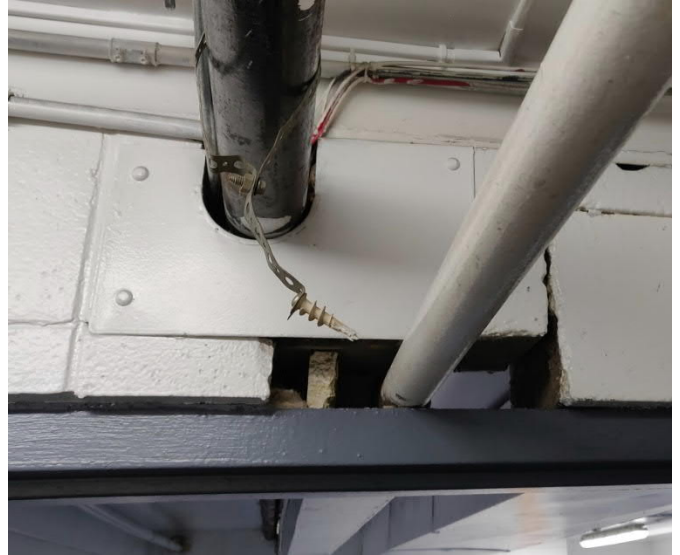
Figure 4-26: Damaged & Inadequate Pipe Hangers

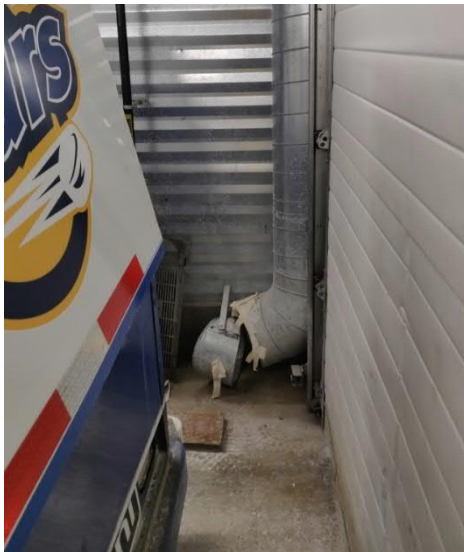
Figure 4-35: Damaged Air Terminal in Zamboni Room

- Provide protection against vehicle impact for the fill station within the Zamboni Room (e.g.: bollards).
- Replacement of the furnace.
- Repair furnace ductwork and reattach missing grille(s).

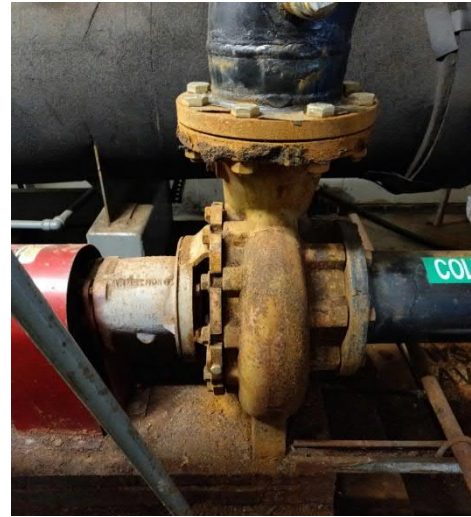
Figure 4-59: Significant Corrosion on Unprotected Pump Casing

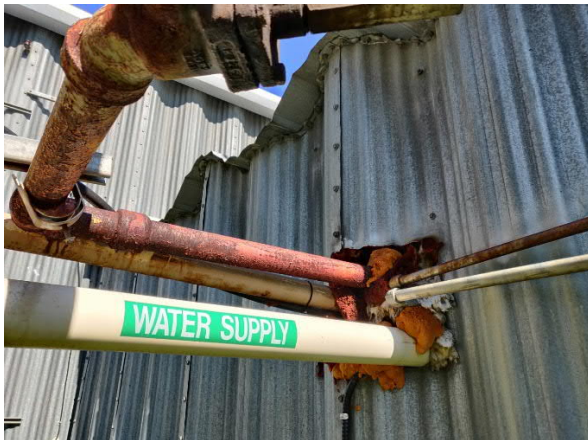
Figure 4-60: Heavily Corroded Piping to Outdoor Condensing Unit & Poorly Sealed Building Opening

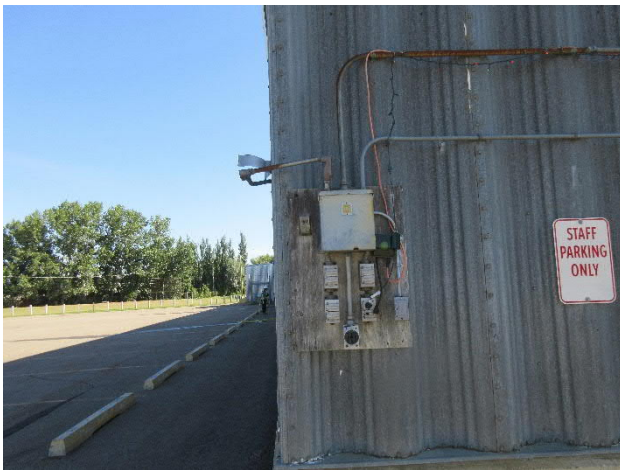
A group of exterior receptacles is currently located at the south-west corner of the building. All receptacles are weather proof except 2 of them. As per CEC, they must be replaced with weather proof type.

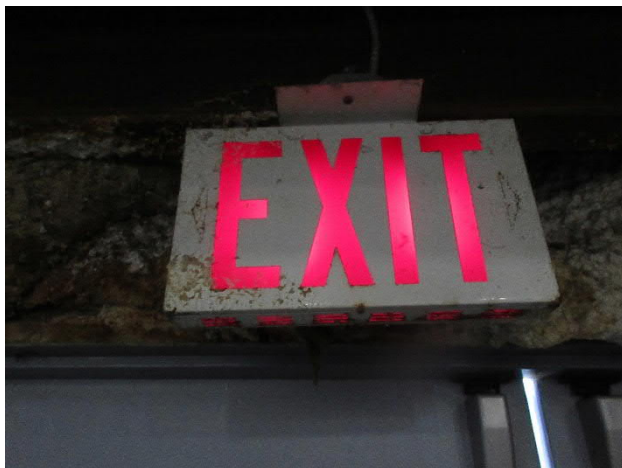
Currently all exit signs are older style “exit” signs. All the exit signs are original to the building where most of them are still operational, but some are broken or defective. The original exit signs are dimly lit, which does not meet building code requirements. It is recommended all original exit signs are replaced. AE recommends replacement with the updated green “running man” (pictogram) style signs as required per National Building Code-2019 Alberta Edition Section 3.4.5.

Figure 5-23: Rusty Exit Sign

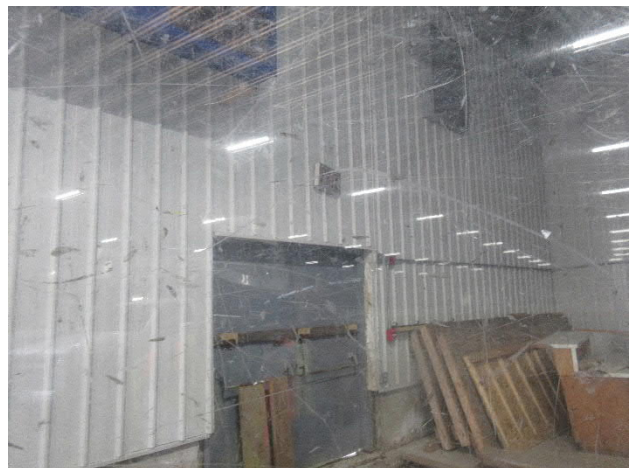
Figure 5-24: Broken Exit Sign
