**Town of Bon Accord**  
**AGENDA**  
**Regular Council Meeting**  
**October 5, 2021 7:00 p.m.**  
Virtual Meeting  
Live streamed on Bon Accord YouTube Channel

This report provides detailed information on low to high and immediate priority repairs or upgrades needed that could be incorporated into capital plans. This includes identifying any immediate safety or operational issues that must be addressed.

Associated Engineering Alberta Ltd. (AE) along with Solis Architecture Ltd. carried out a visual review and condition assessment of the Bon Accord Arena at 4812 52 Street in Bon Accord, Alberta on August 9, 2021. The Town of Bon Accord is considering renovating the Arena and wishes to obtain a summary of the condition of the facility and the budget required to perform the upgrades.

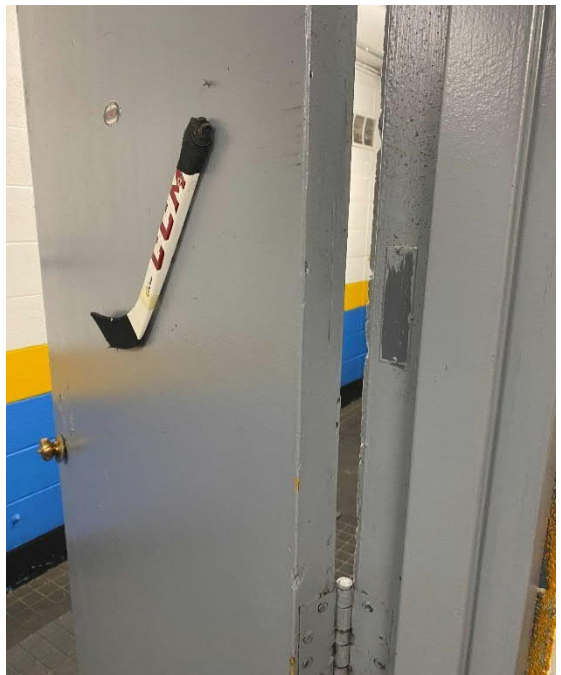
Figure 2-4: Door into Janitor's Room - Rating Covered

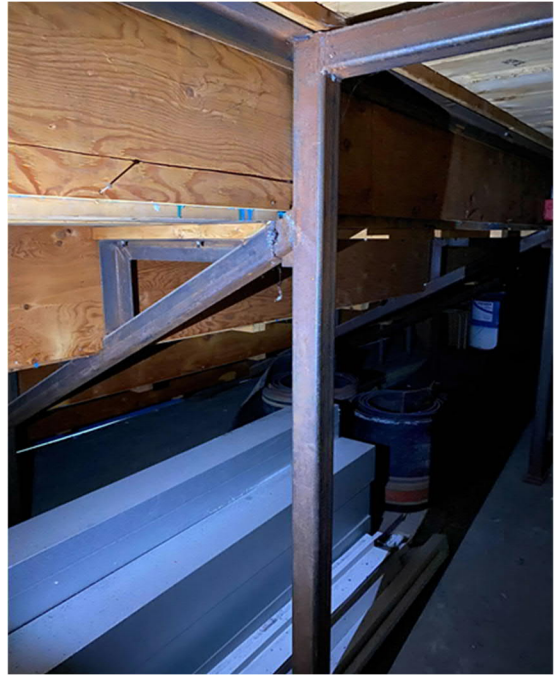
Figure 2-6: Underside of Bleachers - No Fire Rating

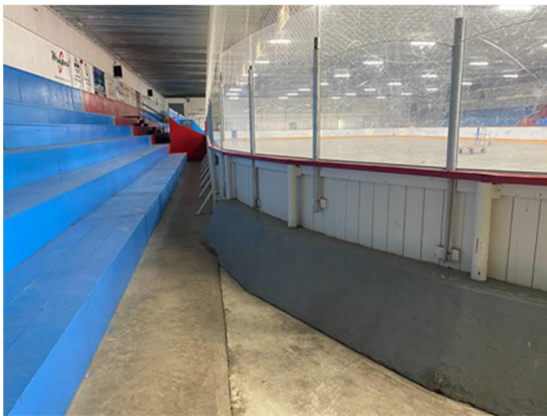
Figure 2-7: Wood Bleachers

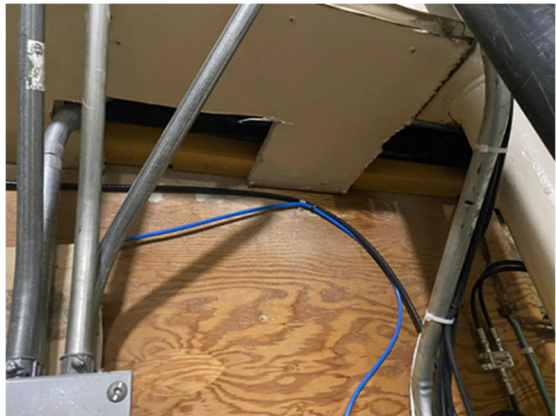
Figure 2-8: Electrical Room Penetrations

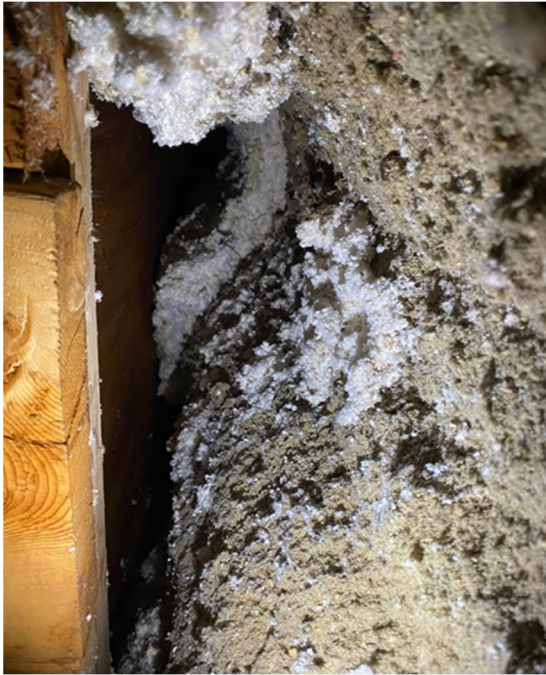
Figure 2-9: Insulation Extending Behind Bleachers

This renovation would revise the location of the vapor barrier to inside the insulation layer aligning with current building envelope detailing and will provide a thermally superior building with less chance of moisture build-up on the inside surface of the metal which will extend the buildings lifespan.

This modification would extend up over the roof to encase the entire building envelope protecting the existing structure and improving the thermal performance and reducing air leakage through the building envelope. The exterior metal cladding would be attached via thermally broken clips to prevent any thermal bridging through the insulation.

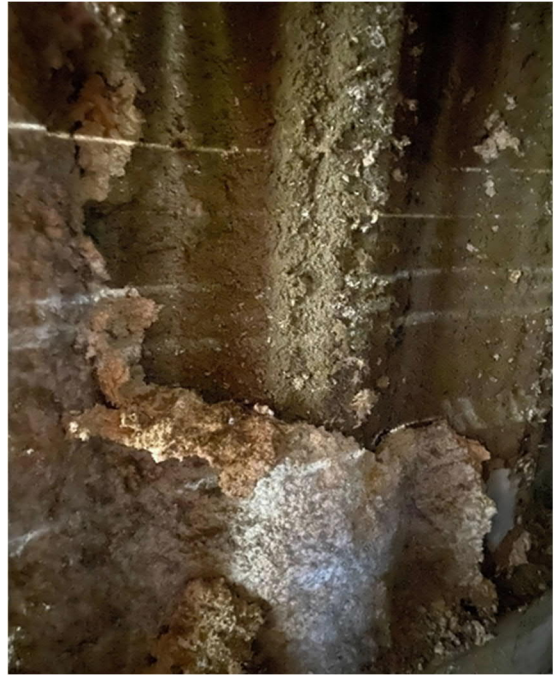
Figure 2-10: Delamination of Insulation Behind Bleachers

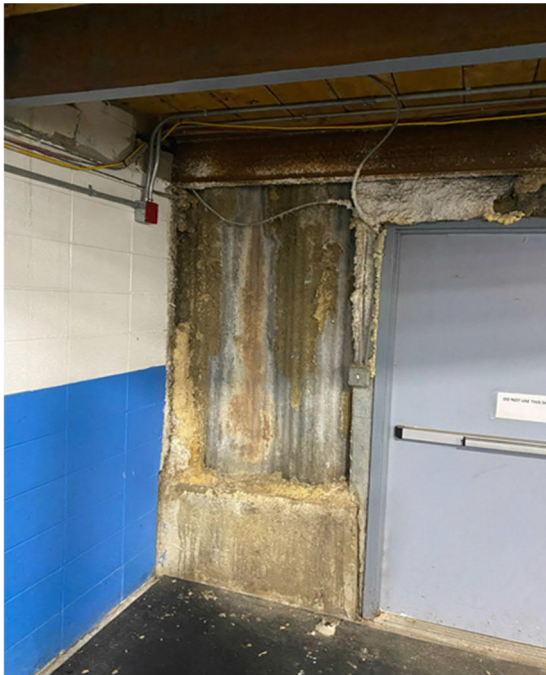
Figure 2-11: Delamination of Insulation at Door

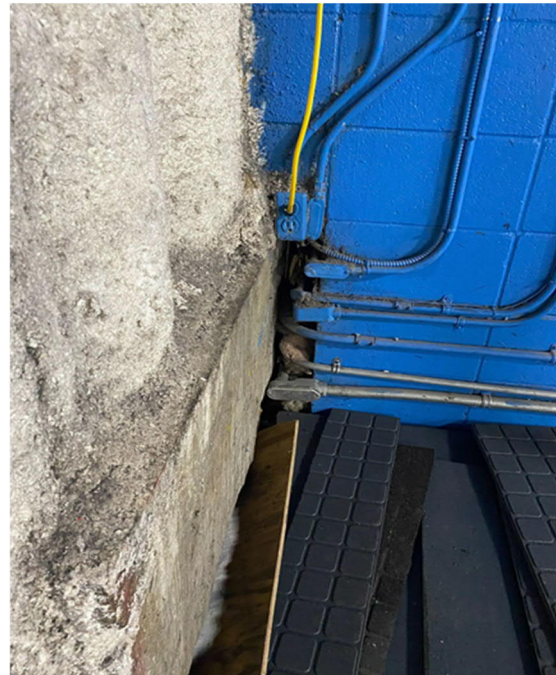
Figure 2-12: Rated Wall Penetration – Seal Penetrations

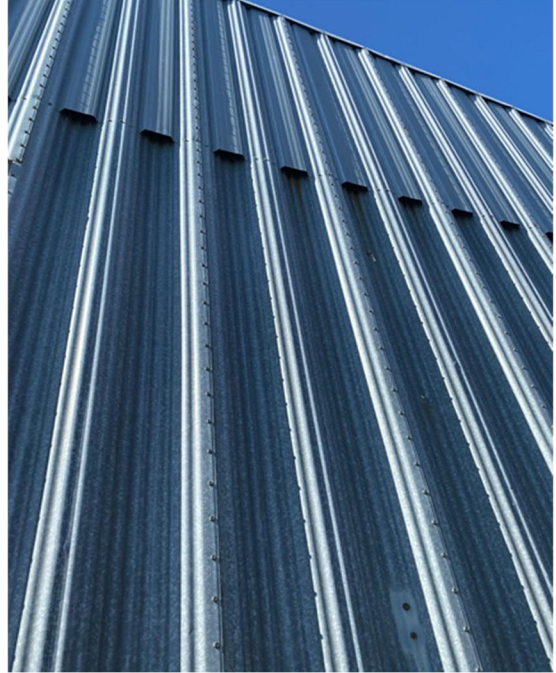
**Figure 2-14: Venting Above the Ceiling/Insulation on the North Side**

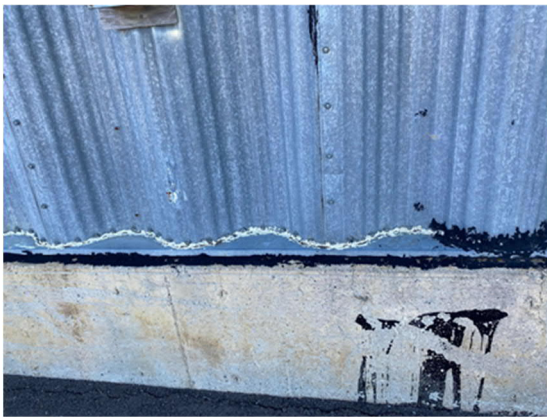
**Figure 2-15: Caulking at Base of Metal Panel on West Facade**

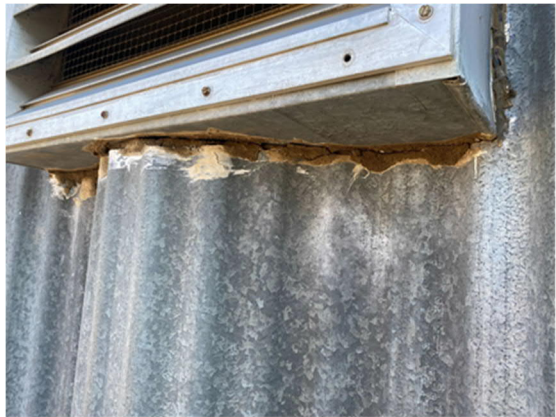
**Figure 2-16: Sealant on South Side Air Duct**

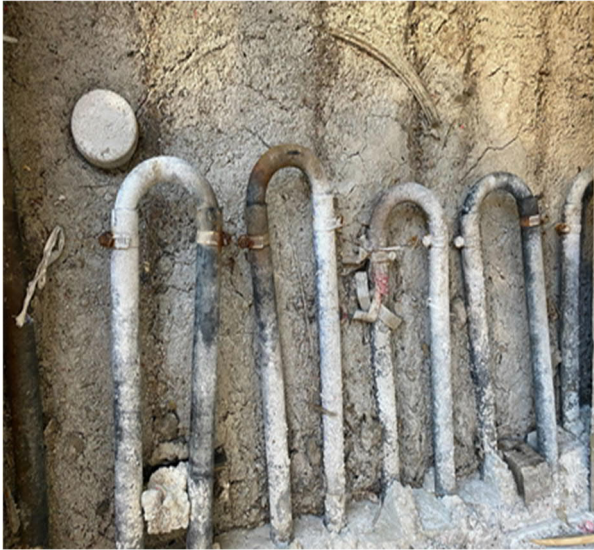
Figure 2-18: Ice Rink Tubes In Slab at North End of Rink

Due to the age of the rink, and the modification already completed to extend the lifespan of the slab, a new concrete slab is recommended. It is not recommended to try to extend the lifespan of the current system as the system has already been retrofitted once and the piping is beyond its lifespan. The installation of a new slab and ice plant is the optimal time to perform a deep energy retrofit for the overall building because a new ice plant can help with the overall heating and cooling of the building with high grade heat recovery and other energy efficiencies optimizing the entire heating and cooling system for the building.

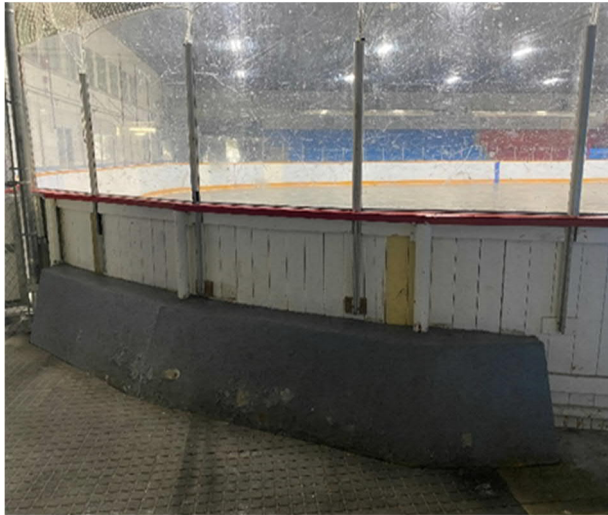
Figure 2-22: Reinforcement at Corners of the Wood Boards

It is recommended that new dasher boards be installed with the installation of a new concrete rink slab. It is not advisable to reuse the existing boards with a new slab.

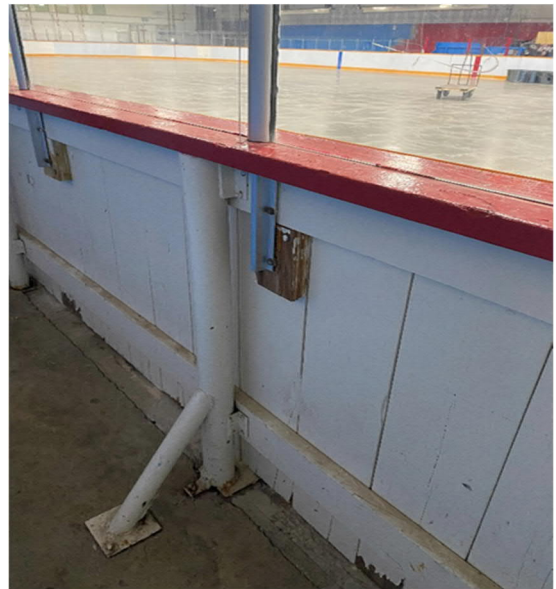
Figure 2-23: Wood Dasher Board System

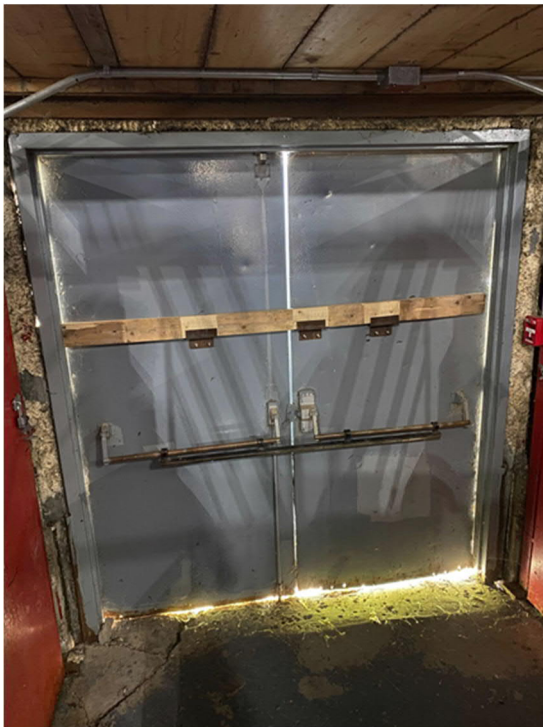
Figure 2-26: Door in East Side beside Bleachers

- Replace the seals on all the exterior doors in the front Lobby area.
- Replace all the exterior doors in the ice rink.
- Install a vestibule at major entry and exit points within the building.
- Repair the doors and add the fire rating labels to the doors. (Refer to [Section 2.2 Code Violation.](#))

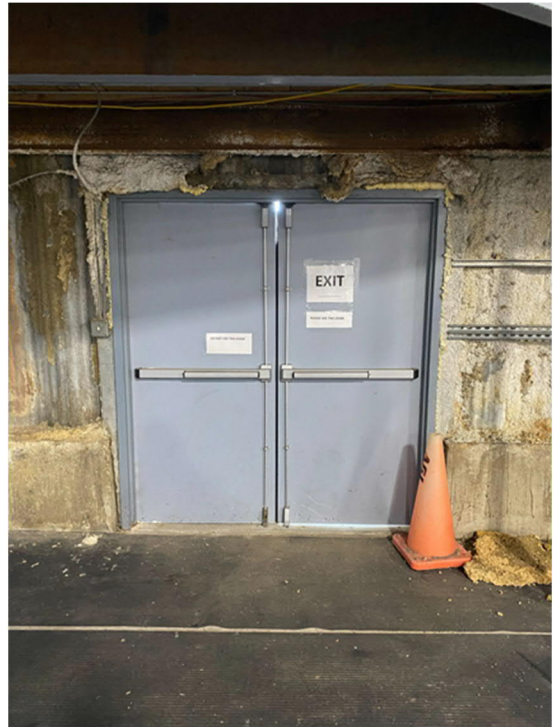
Figure 2-27: Door on West Side

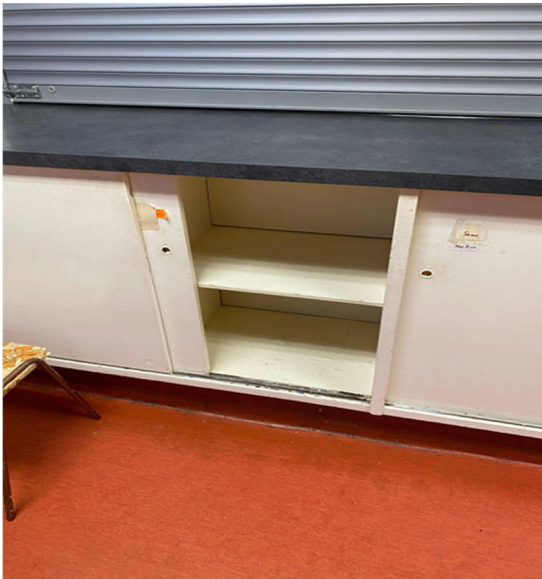
Figure 2-28: Millwork in Concession Area

- Replace existing skate flooring throughout the entire facility.
- Renovate the washrooms.
- Renovate the change rooms including removing the existing tiles.
- Replace the millwork in the Concession area.
- Replace the flooring on the 2<sup>nd</sup> Floor Concession area.
- Replace damaged ceiling tiles.
- Revise the existing ice plant to storage (refer to [Section 2.2](#) Code Violation).

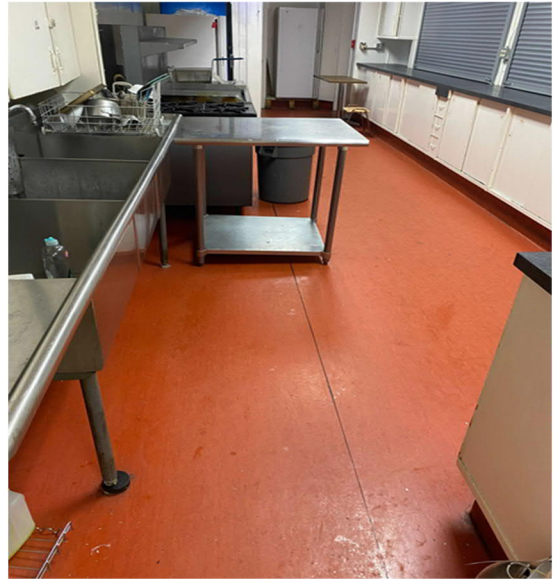
Figure 2-29: Flooring in Concession Area

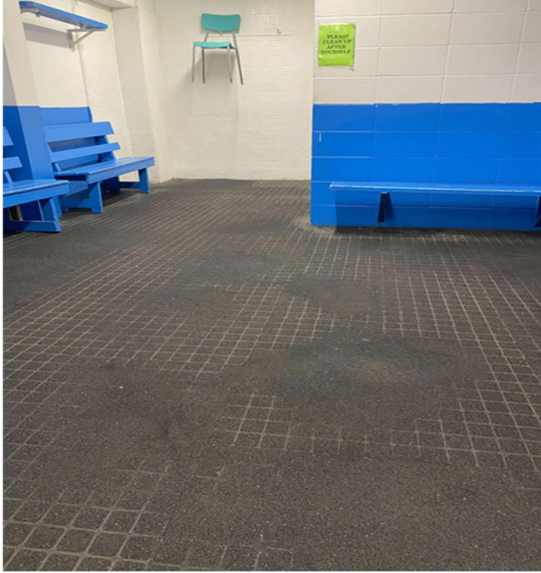
Figure 2-30: Skate Flooring & Benches

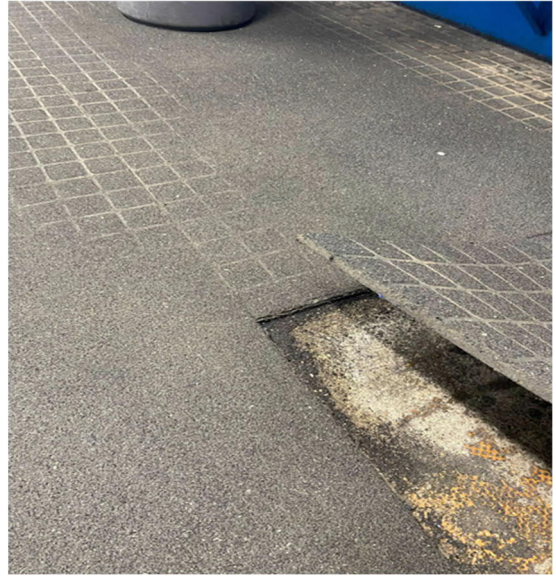
Figure 2-31: Skate Flooring Peeling Up with Gaps at the Corners

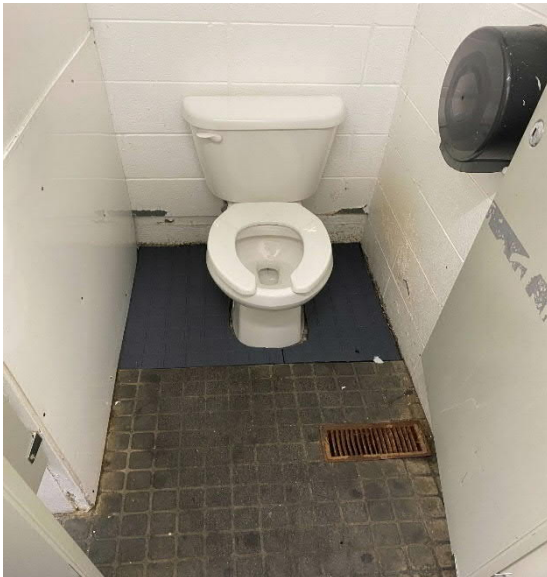
Figure 2-32: Typical Change Room Washrooms

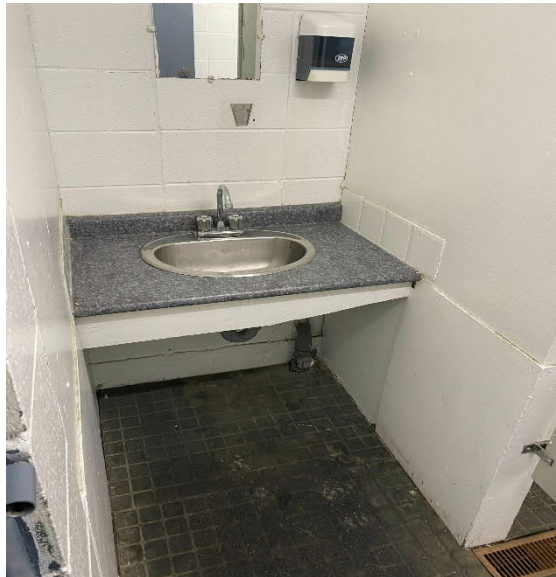
Figure 2-33: Typical Change Room Sink

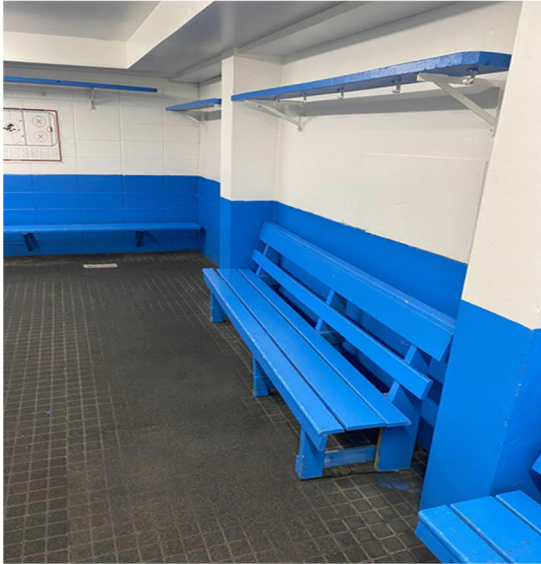
Figure 2-34: Change Room Benches

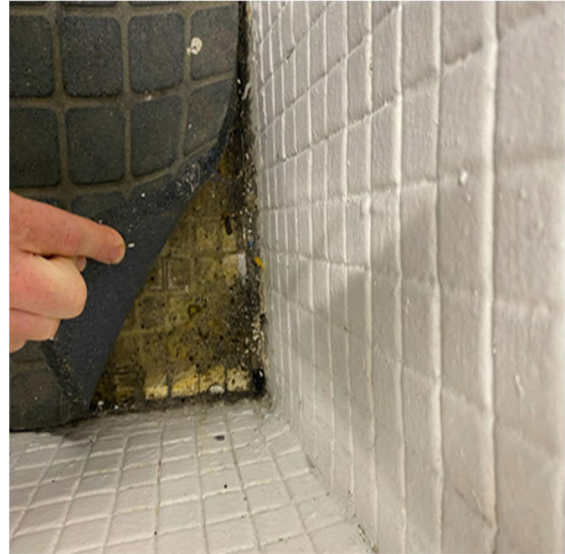
Figure 2-35: Skate Flooring over Existing Showers

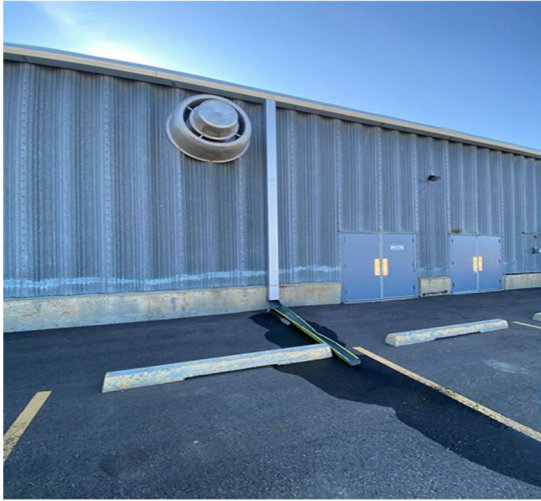
Figure 2-36: Drainage Issue on West Side

Provide a drainage corridor on the west side of the building to capture the roof run off and prevent the asphalt parking lot from becoming an outdoor skating rink and incorporate an internal gutter and heat trace, as part of the new renovation to prevent water from splashing onto the asphalt parking lot.

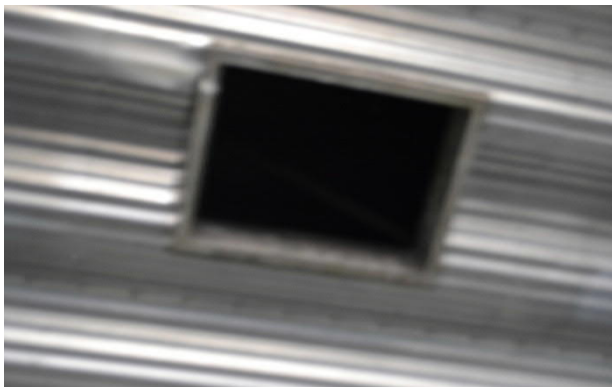
- Roof access is difficult to open. It is suspected that the access hatches are rusted.
- The light gauge framing steel around the hatch is rusted.
- Minor signs of rusting are present on the steel roof trusses. At the time of inspection, the ceiling cavity and the insulation were dry. In a previous report, by McNamara Project Management Ltd., in March 1990, the insulation was moist. Due to the light rusting observed, AE believes that a moisture issue is still present, but AE did not observe any moisture in the insulation. AE believes that was due to the warm summer and the non-operation of the arena over the winter that the moisture did not accumulate as it usually would.

Figure 3-5: Roof Access Hatch Overview

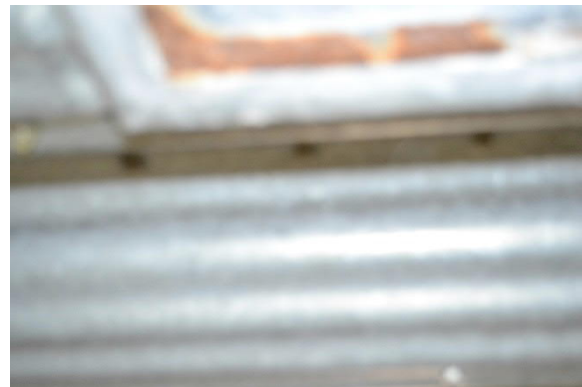
Figure 3-6: Rusting on Roof Access Hatch Framing

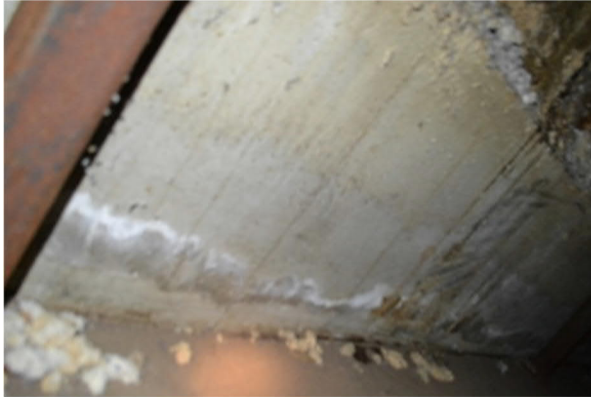
- Efflorescence on foundation wall under the bleachers.
- Concrete scaling and spalling around the building foundation walls, particularly at door locations
- Shrinkage cracking around foundation wall exterior typical.
- Concrete discolouration of foundation wall exterior typical.

**Figure 3-15: White Residue on Concrete Foundation Under Bleachers**

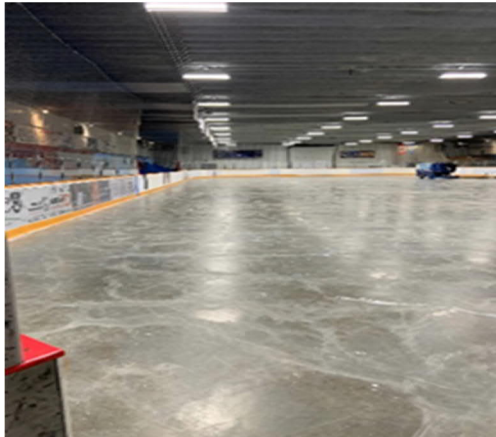
Figure 3-19: Shrinkage Cracking on Ice Arena Slab

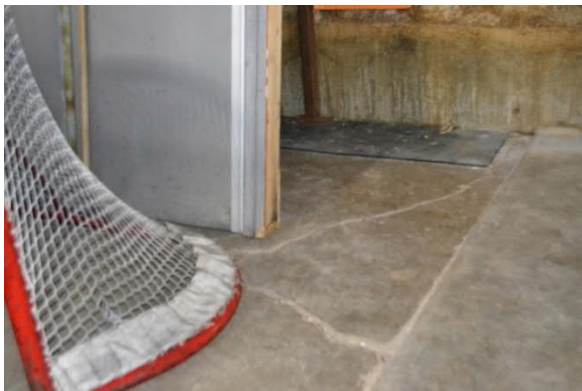
- Concrete under the bleachers is severely cracked.
- Severe cracking of slab on grade particularly under the stairs and the south east section of the building. Largest crack was approximately 2mm wide and 120mm deep.
- Severely cracked concrete slab thickening at entrance.
- Rusted grating in front of the north main entrance.

Figure 3-21: Cracked Slab at Storage Area at South East Corner of Arena

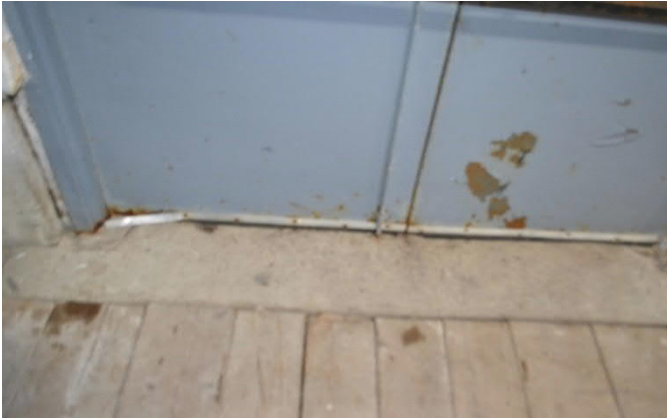
Figure 3-23: Slab Thickening Overview

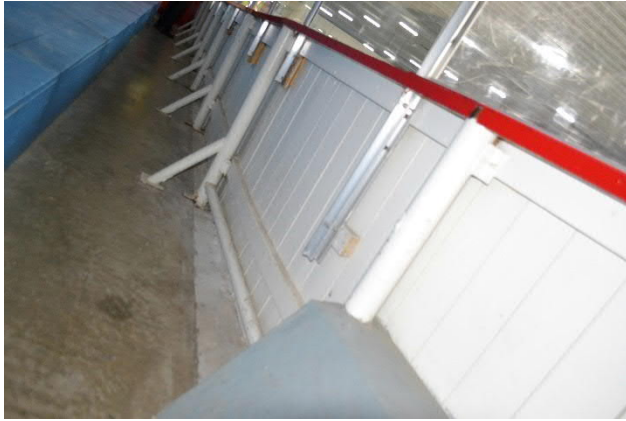
- Painting on the older wood dasher boards is spalling off.
- Minor signs of rusting on dasher boards supports.

Figure 3-26: Dasher Boards Overview

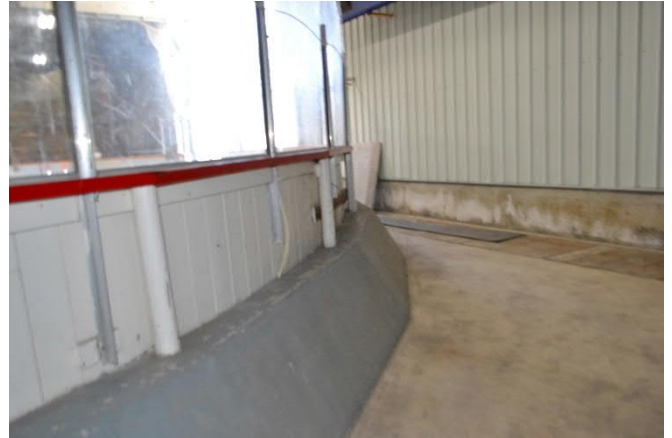
Figure 3-27: Dasher Boards Supports Encased in Concrete

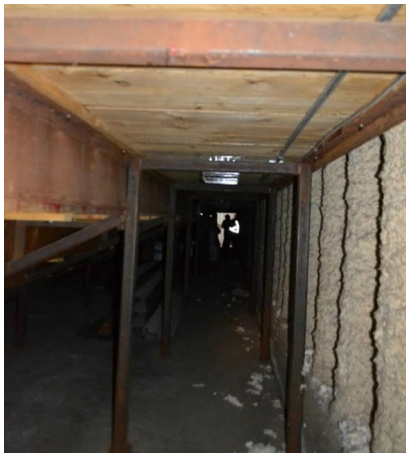
- Base of Bleachers post and baseplate missing anchor bolts.

Figure 3-28: Underside of Bleacher Overview

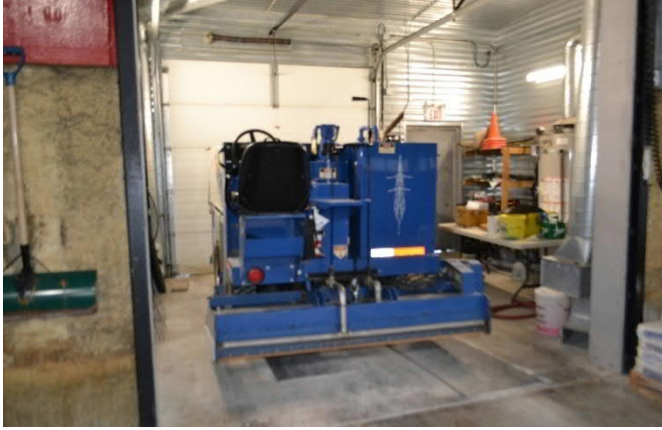
- Slab on grade is cracked. The cracks are approximately 0.7mm wide and vary in length.
- The concrete slab on grade and equipment housekeeping are discoloured.

Figure 3-30: Plant Room Overview

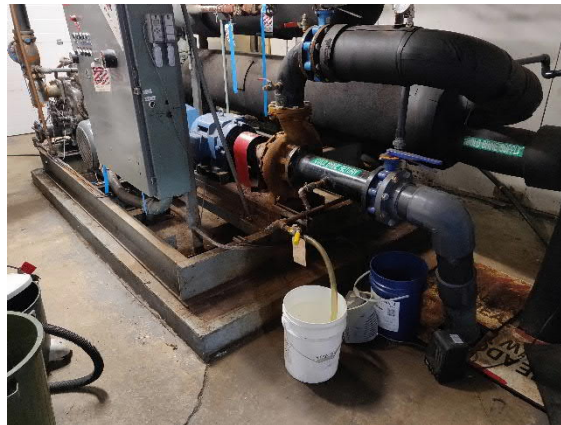
- Slab on grade is cracked at the corner of equipment pad.

Figure 3-32: Ice Plant Room

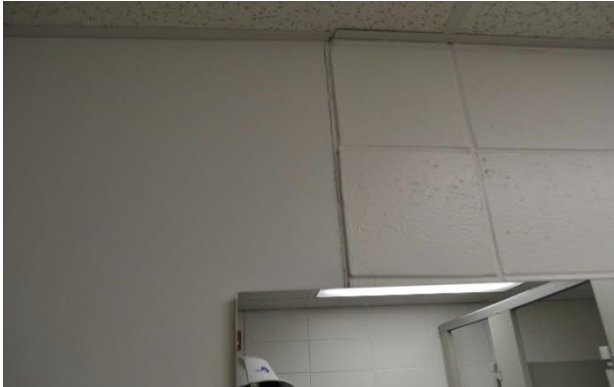
Figure 3-33: Crack Between Masonry Wall & Concrete Wall

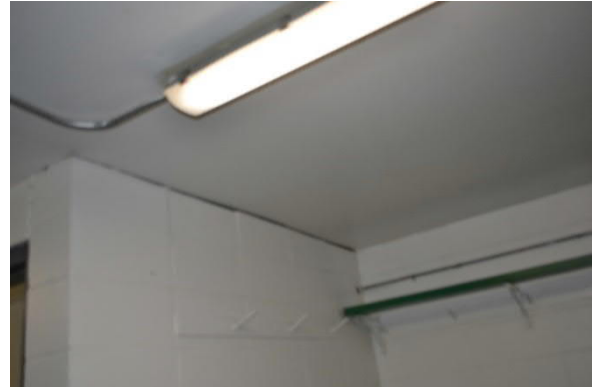
Figure 3-34: A Gap Between Ceiling & Masonry Wall

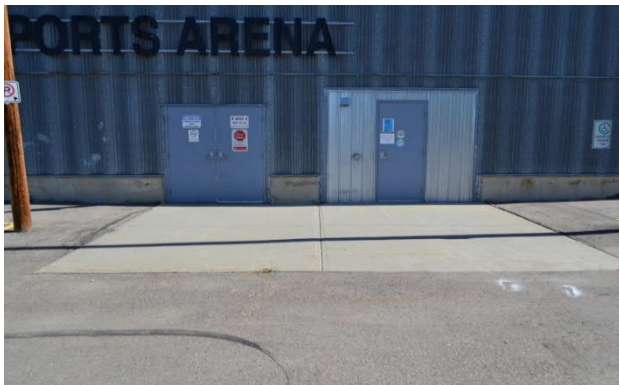
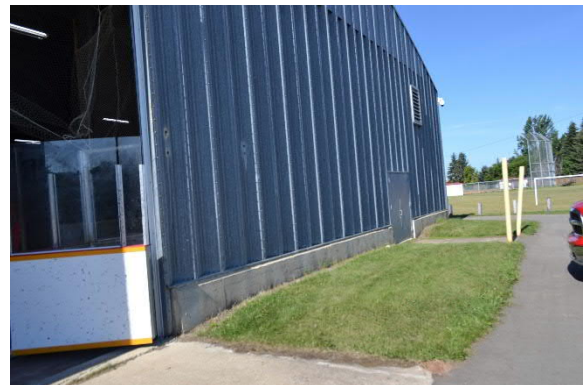
- Deteriorated exterior pad is on the north side of building is severely fragmented. There is likely no reinforcement in the concrete pad.
- Generally, there is organics growing between the perimeter foundation wall and exterior slabs.

Figure 3-35: Exterior Concrete Pad

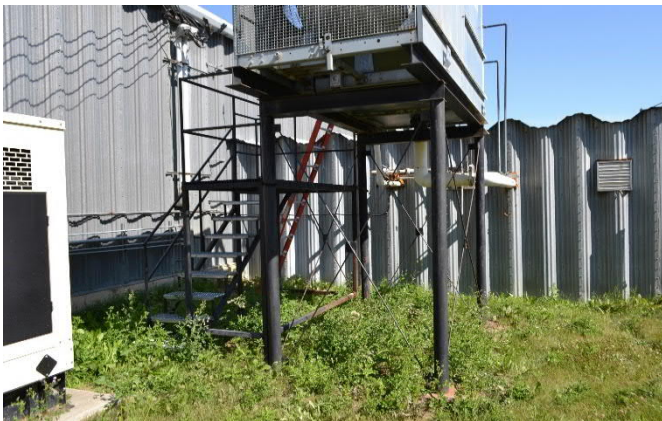
- Severe rusting on base plate.
- Minor sign of rusting in the framing steel.

Figure 3-39: Exterior Steel Structure Overview

The steel should be wire brushed to determine the extent of the effects of the rust. If damage is significant then repairs should be undertaken.

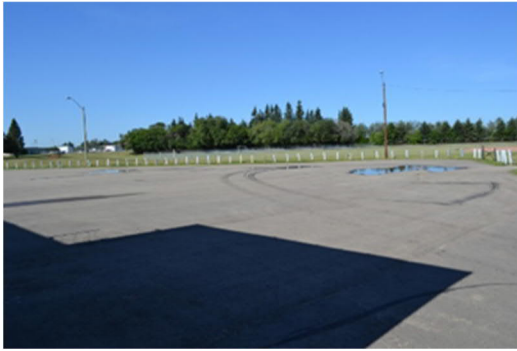
- Deteriorated asphalt at emergency door locations at southeast parking lot as result of poor drainage. Water pools at the parking lot. During winter ice collects resulting in a very icy parking lot. This is a safety concern.
- Damage swale with exposed rebar at the east portion of the building.

Figure 3-41: Parking Lot Overview

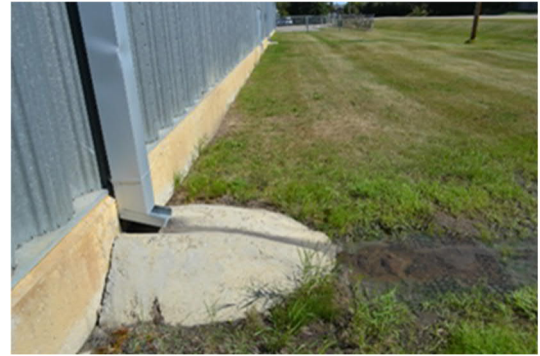
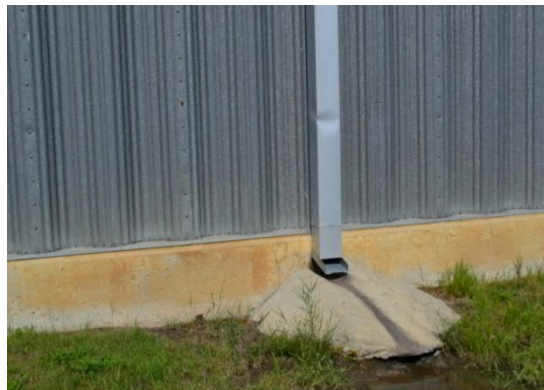
- Foundation undermining of swale grate at the west portion of building.

Figure 3-42: Undermined Swale

Figure 3-43: Undermined Swale

Struc.	Exterior	Remove & replace undermined swale grates	Medium	\$4,000
Struc.	Exterior	Replace damaged corrugated metal sheathing on the building envelope.	Low	\$10,000
Struc.	Interior	Paint concrete wall or refinish concrete wall to address concrete discoloration.	Low	\$3,500
Struc.	Foyer Area	Caulk masonry mortar joints that are de-bonded between block wall & the ceiling.	Low	\$3,000
Struc.	Exterior	Remove organics growing between the perimeter foundation wall & entrance slabs. Gaps should also be sealed off.	Low	\$1,500
			<b>TOTAL IMMEDIATE PRIORITY</b>	<b>\$110,000</b>
			<b>TOTAL HIGH PRIORITY</b>	<b>\$19,500</b>
			<b>TOTAL MEDIUM PRIORITY</b>	<b>\$40,000</b>
			<b>TOTAL LOW PRIORITY</b>	<b>\$18,000</b>
			<b>TOTAL</b>	<b>\$187,500</b>

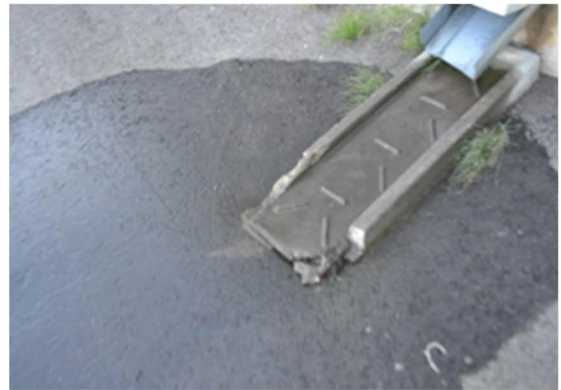
Figure 3-44: Damaged Swale

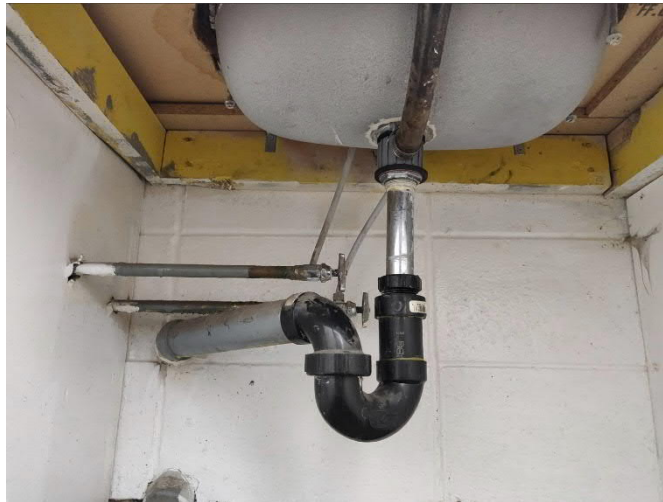
The building has a buried sanitary main which collects drainage from the plumbing fixtures installed in the building and connects to the municipal service on site. Most of the sanitary system could not be observed, but the exposed drain piping at plumbing fixtures was generally in acceptable condition. Based on the age of the building, the sanitary main is assumed to be cast iron, but sanitary connections to plumbing fixtures is observed to be a combination of PVC and ABS. Since the condition of the buried piping is not known, we recommended assessing the buried sanitary piping condition with a camera snake before proceeding with any major renovations involving the sanitary system.

Figure 4-1: Typical Exposed Lavatory Drain

- Confirm condition of buried sanitary piping via camera snake before proceeding with major renovation involving the buried sanitary system.

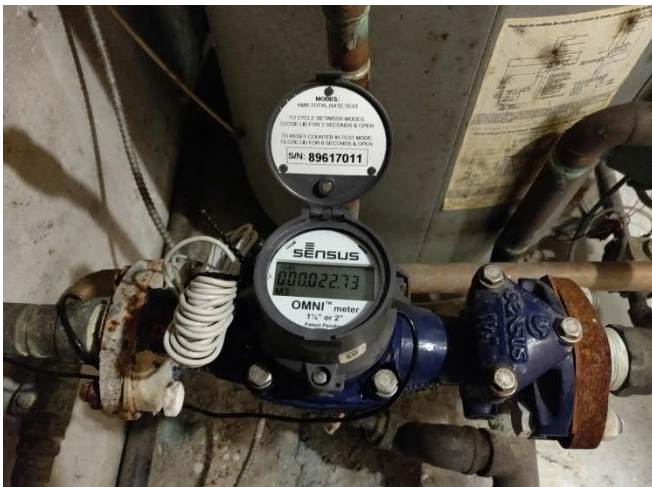
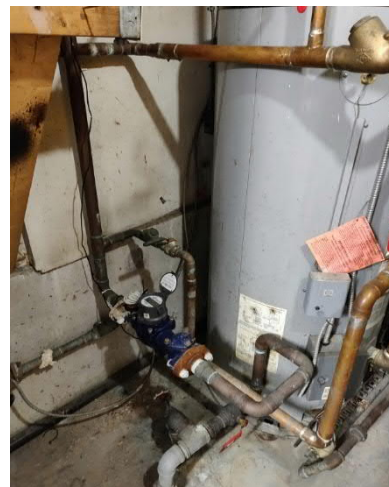
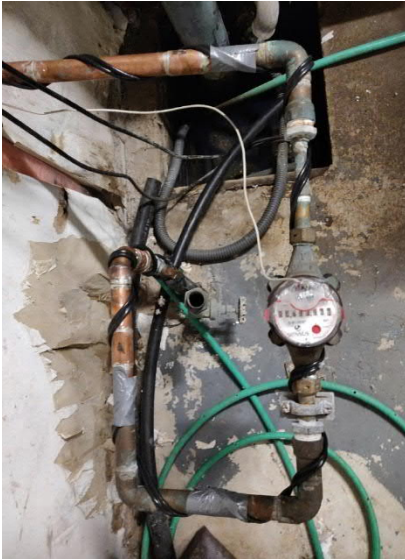
Domestic water for the building is supplied by a 40 mm water entry within the Mechanical Room in the Locker Room area on the southwest side of the building. The water meter appears to have been replaced very recently as the meter read only 22 m<sup>3</sup> at the time of the inspection. The water service does not appear to be protected by a backflow preventer, which is recommended by the current plumbing code.

The ice plant appears to have a separate water entry from below grade complete with a water meter for make-up water. AE recommends adding a suitable backflow preventer to the ice plant make-up water.

Figure 4-2: Building Water Meter

Figure 4-3: Water Entry & Domestic Cold Water Piping

Figure 4-4: Ice Plant Water Entry & Meter

- Install backflow prevention to CSA B64 on the municipal water supply and make-up water for the ice plant.
- Replace the original sections of hot and cold copper plumbing piping and insulate the new piping.
- Investigate the cause of water marks on ceilings and repair plumbing piping as required.
- Replace damaged or missing pipe hangers throughout the facility.

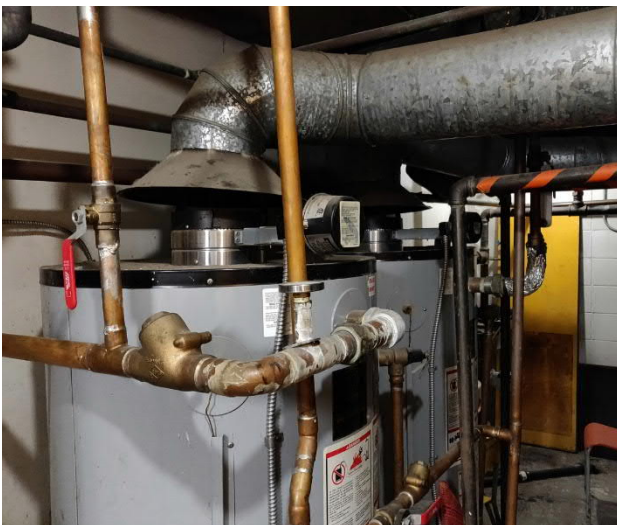
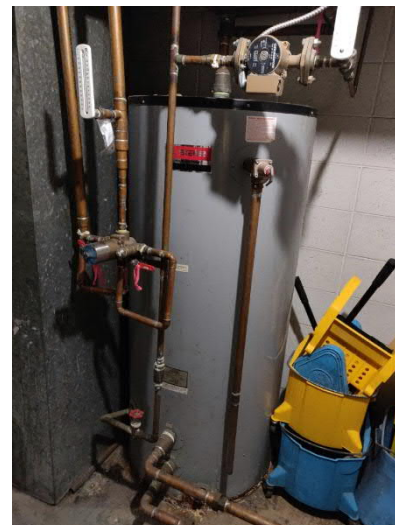
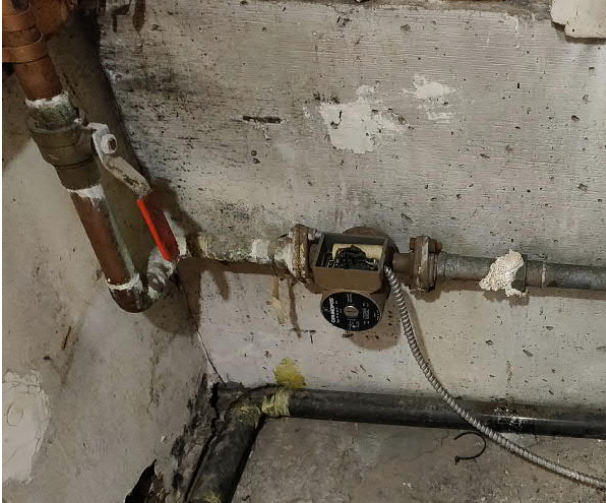
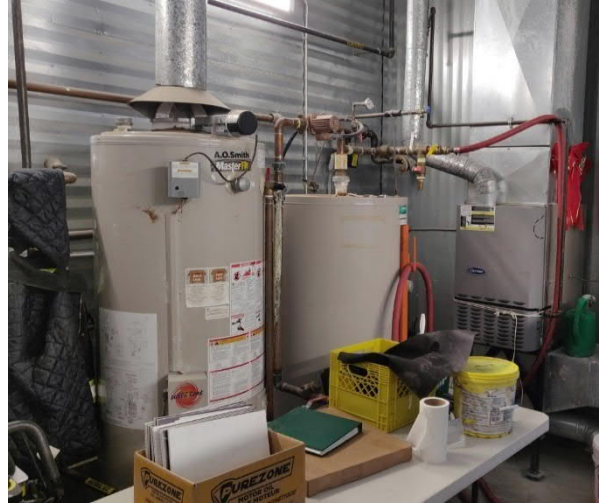
Figure 4-8: Water Heaters in Mechanical Room

Figure 4-9: Water Storage Tank, Mixing Valve & Circulation Pump in Mechanical Room

Figure 4-10: Domestic Hot Water Recirculation Pump in Mechanical Room

Figure 4-11: Domestic Hot Water Heater, Storage Tank & Circulation Pump in Zamboni Room

- Install backflow prevention to CSA B64 on the municipal water supply and make-up water for the ice plant.
- Hire an engineer to review the capacity of the domestic water heating system for the building at the next system replacement.
- Replace domestic water heaters, circulator pumps, storage tanks and mixing valve.

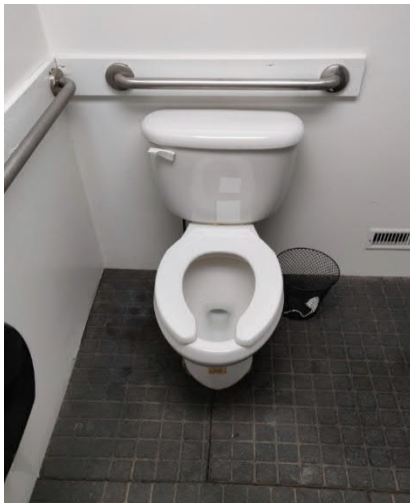
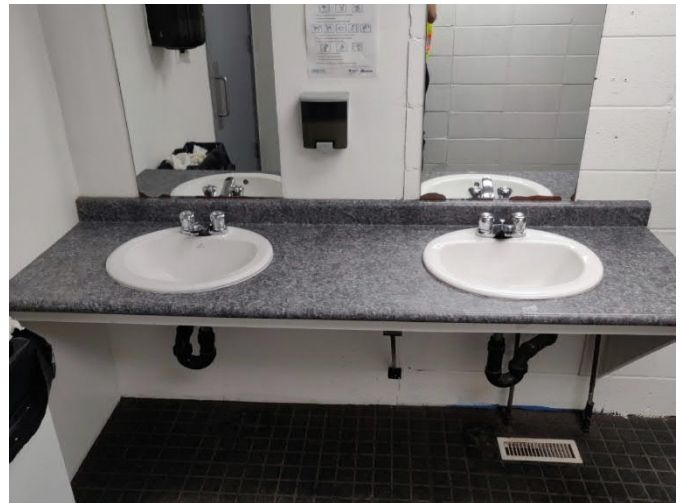
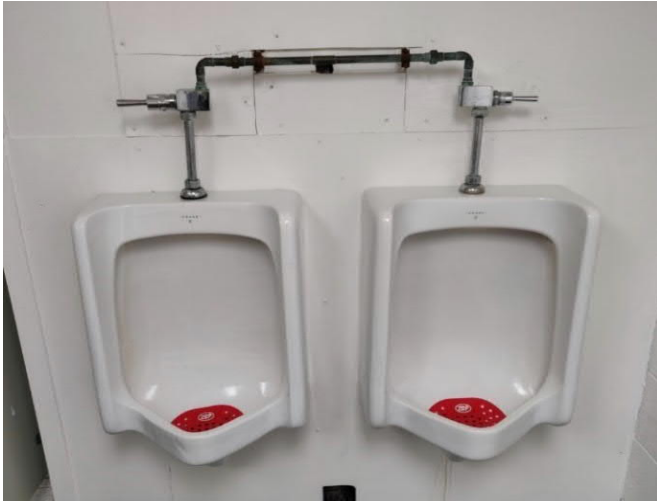
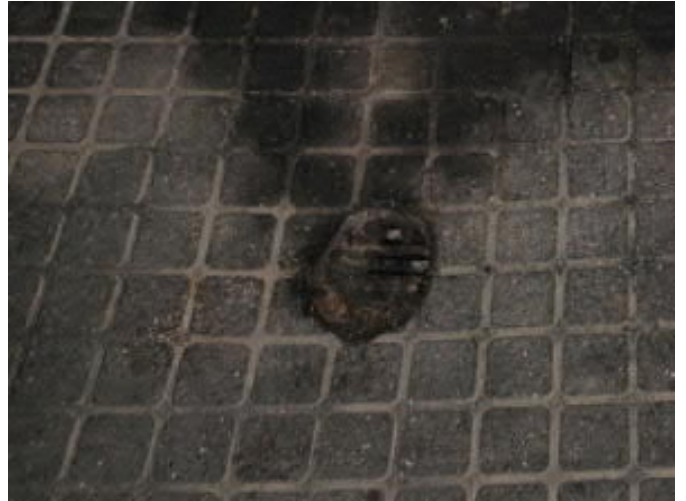
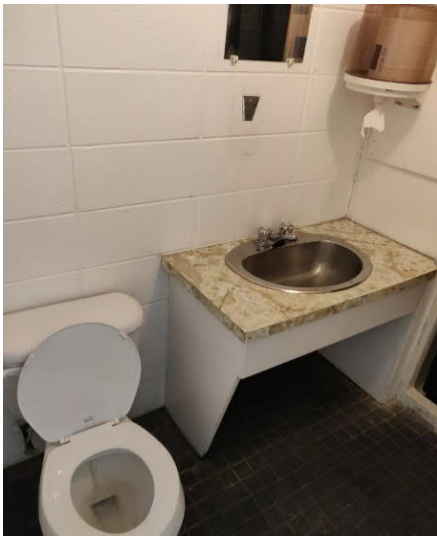
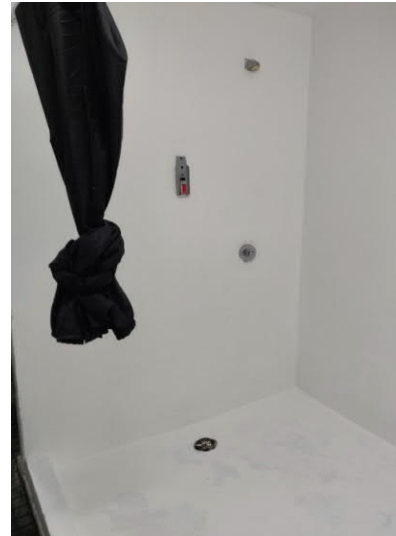
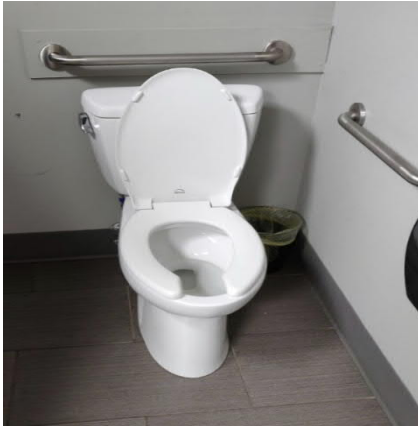
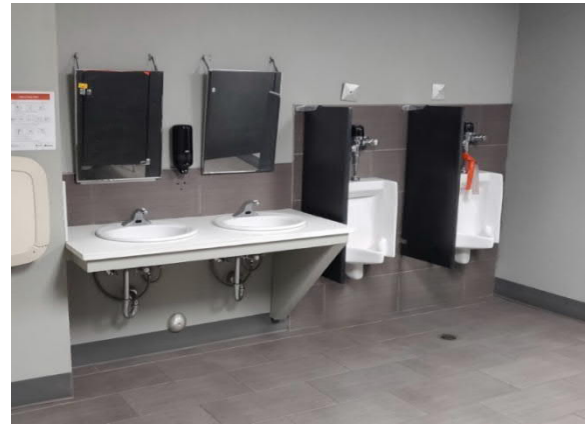
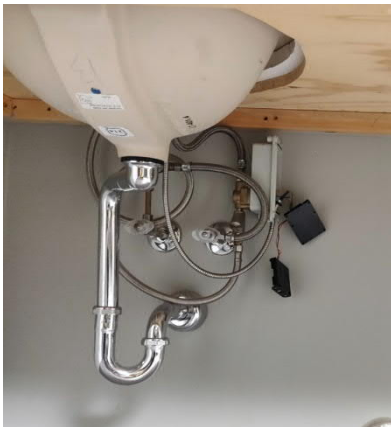
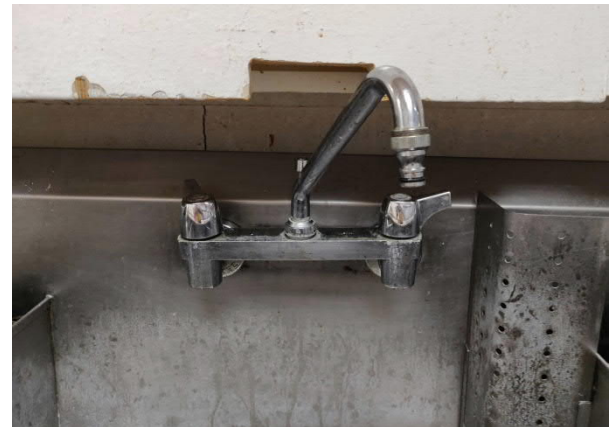
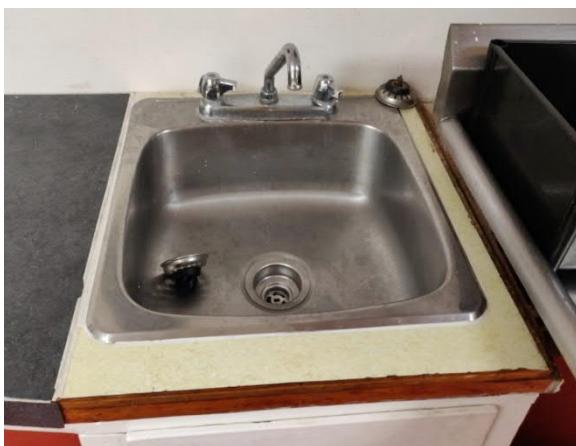
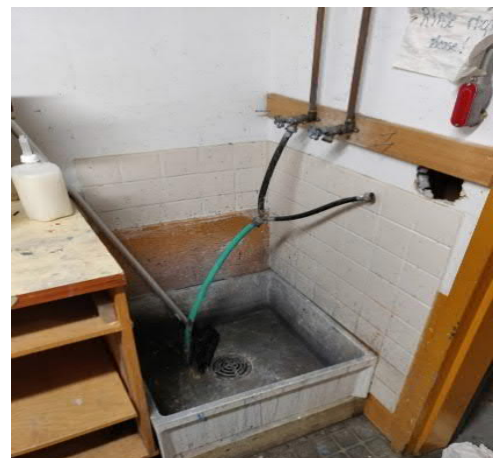
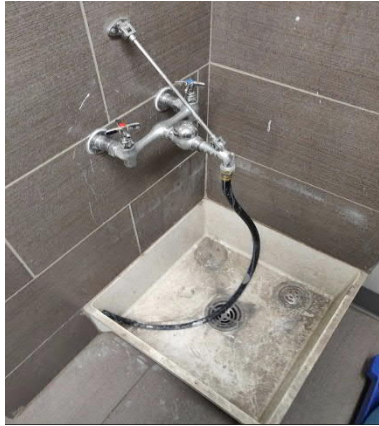
Figure 4-12: Typical 6.0 LPF Water Closet

Figure 4-13: Typical Main Floor Washroom Lavatories

Figure 4-14: Mens Washroom Urinals

Figure 4-15: Typical Floor Drain on Main Floor

Figure 4-16: Typical Locker Room Lavatory & Water Closet

Figure 4-17: Typical Locker Room Shower

Figure 4-18: Typical 2<sup>nd</sup> Floor Water Closet

Figure 4-19: Plumbing Fixtures in 2<sup>nd</sup> Floor Mens Washroom

Figure 4-20: 2<sup>nd</sup> Floor Lavatory Battery Holster

Figure 4-21: Kitchen Three-Compartment Sink Faucet

Figure 4-22: Kitchen Prep Sink

Figure 4-23: Main Floor Janitor Room Mop Sink

Figure 4-24: 2<sup>nd</sup> Floor Janitor Room Mop Sink

- Replace missing drain stoppers in Main Floor lavatories.
- Replace the following plumbing fixtures due to age and condition:
  - Main Floor Public Washrooms: Floor drains.
  - Main Floor Public Washrooms: Lavatories, water closets, urinals – low priority.
  - Locker area: Showers, lavatories, water closets and floor drains (excluding referee shower).
  - Kitchen: Sinks and faucets – low priority.
  - Main Floor Janitor Room: Mop sink and faucet (hose bibs).
- Secure battery holsters for the 2<sup>nd</sup> Floor lavatories.
- Clean the 2<sup>nd</sup> Floor mop sink basin.

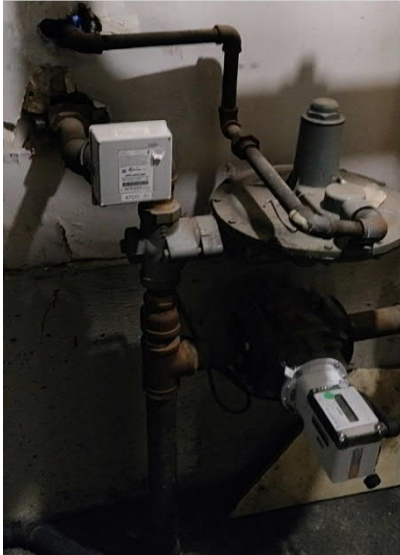
Figure 4-25: Gas Meter & Regulator in Mechanical Room

- Complete soap bubble test and fix any gas piping leaks within Mechanical Room.
- Replace natural gas piping where original to the building or corroded.
- Complete an engineering review of combustion air for the Zamboni Room and Mechanical Room.

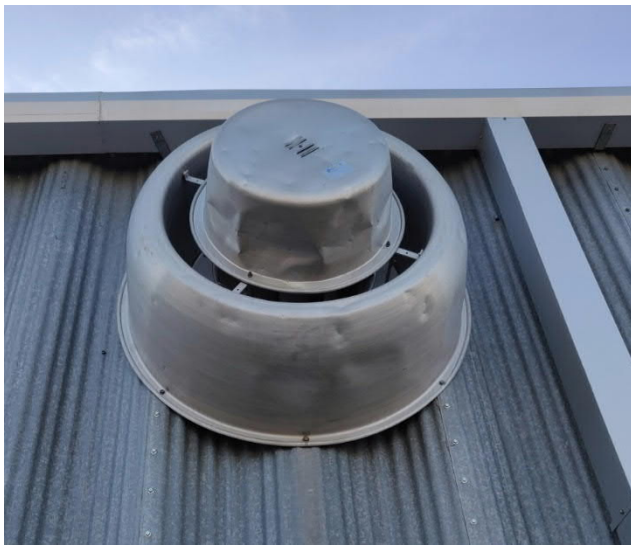
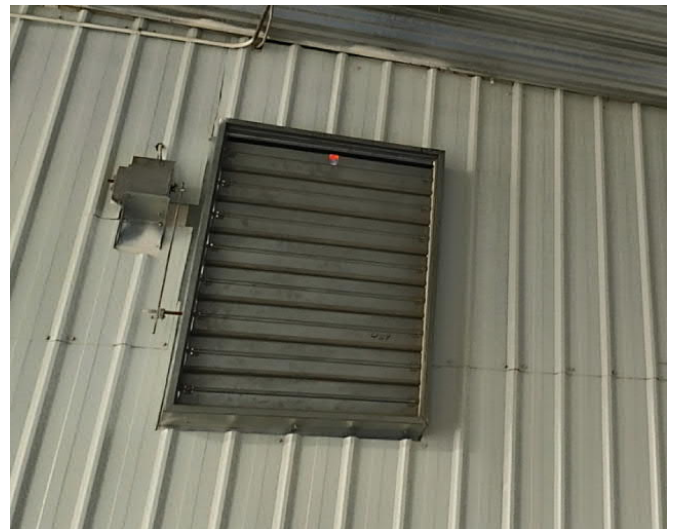
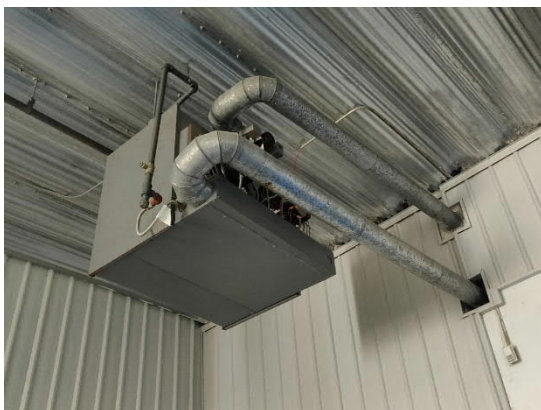
Figure 4-27: Typical Arena Exhaust Fan

Figure 4-28: Typical Arena Motorized Louvre

Figure 4-29: Typical Arena Unit Heater & Thermostat

- Complete a ventilation study to determine if outdoor air rates for Zamboni ventilation and ASHRAE 62 are met.
- Complete staff training to ensure the fans are operated when the arena is scheduled to be used.
- Install CO/NOx sensors and alarms in the arena.
- Replacement of arena exhaust fans and louvre actuators in approximately 5 years.
- Replacement of arena unit heaters and infrared tube heaters.
