**Town of Bon Accord**  
**AGENDA**  
**Regular Council Meeting**  
**October 5, 2021 7:00 p.m.**  
Virtual Meeting  
Live streamed on Bon Accord YouTube Channel

This report provides detailed information on low to high and immediate priority repairs or upgrades needed that could be incorporated into capital plans. This includes identifying any immediate safety or operational issues that must be addressed.

Associated Engineering Alberta Ltd. (AE) along with Solis Architecture Ltd. carried out a visual review and condition assessment of the Bon Accord Arena at 4812 52 Street in Bon Accord, Alberta on August 9, 2021. The Town of Bon Accord is considering renovating the Arena and wishes to obtain a summary of the condition of the facility and the budget required to perform the upgrades.

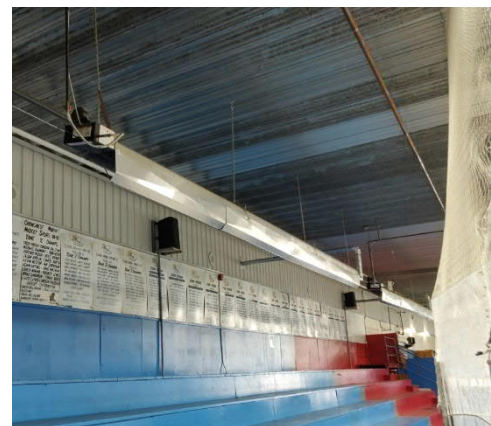
Figure 4-30: Tube Heaters for Northwest Stands

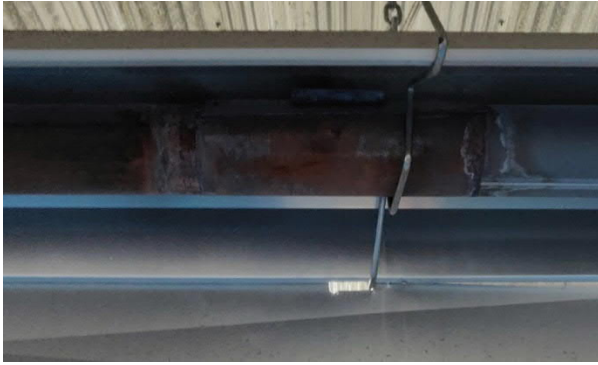
Figure 4-31: Corrosion on Tube Heater Surface

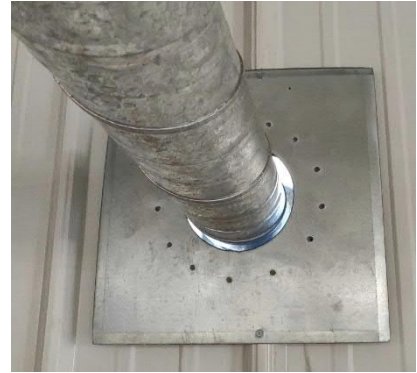
Figure 4-32: Poorly Sealed Tube Heater Flue Opening

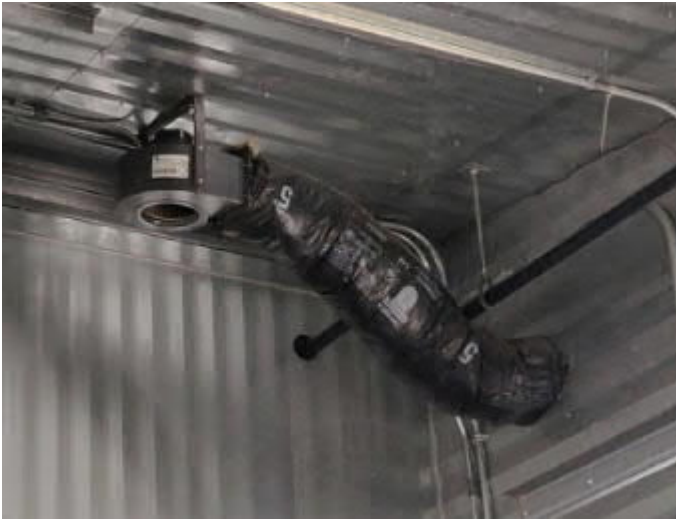
The Zamboni Room has a centrifugal blower at high level, which exhausts to the outdoors, apparently to meet the requirements indicated above. The fan is likely installed to ventilate Zamboni exhaust from the space. The blower appears to be recently installed and is in good condition. It was not confirmed if the ventilation rate is adequate to ventilate the Zamboni, but this should be included in the ventilation study recommended in the previous section.

Figure 4-33: Zamboni Room Exhaust Blower

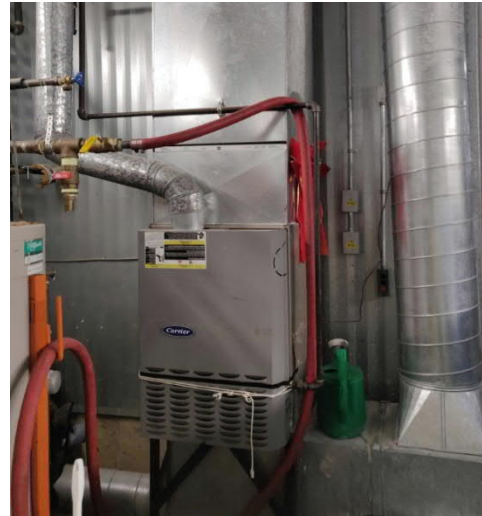
The Zamboni Room is heated with an 80% efficient 135 MBH Carrier Comfort furnace from 2002, which is vented into a combined flue for the furnace and domestic nearby water heater. The furnace has some supply and return ductwork installed, but the ducts are open ended, damaged, and have no grilles or balancing devices. The furnace is currently at the end of its lifespan of 18 years and is due for replacement.

Figure 4-34: Zamboni Room Furnace &amp; Ductwork

- Provide protection against vehicle impact for the fill station within the Zamboni Room (e.g.: bollards).
- Replacement of the furnace.
- Repair furnace ductwork and reattach missing grille(s).

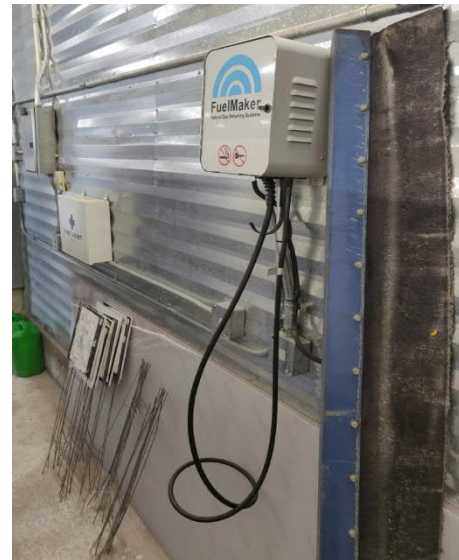
The Zamboni Room has an exterior wall-mounted fuel compressor station and remote fill station within the Zamboni Room to provide fuel to the Zamboni. The fuelling station must meet the requirements of CSA B149, which appears to generally conform with the exception that there is no protection against vehicle impact with the fill station. AE recommends adding bollards or other protection to protect against vehicle impacts meeting CSA B149.

Figure 4-36: Zamboni Fuelling Station

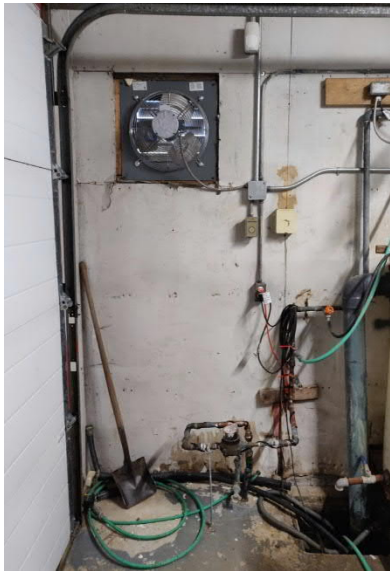
The ice plant equipment room is equipped with a Canarm propeller wall fan from 2018, and a wall-mounted louvre on the opposing wall. The room is heated with a condensing-efficiency direct-vented Carrier Weathermaker 9200 furnace, controlled by a wall-mounted thermostat. The furnace is missing the front panel cover and is showing corrosion on the internal components. The age of the furnace is unknown, but it is dated and in poor condition.

Figure 4-37: Ice Plant Room Ventilation Fan

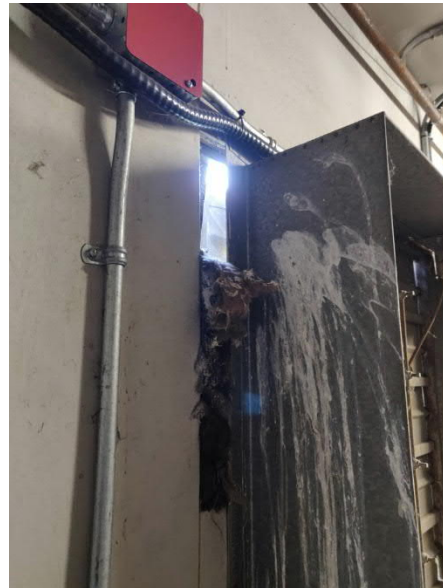
- The installed furnace is not permitted in the room as it produces a flame.
- HVAC penetrations of the room walls must be tightly sealed. Light can be seen through the gap around the installed louvre and water marks are visible on the side of the louvre indicating that rain is entering the building through the gap. Spray foam was used to seal the pipe penetration location, but it appears that several repairs were done, possibly due to vibrations in the pipes causing deterioration of the seal.
- The ventilation fan requires a remote activation control, located outside the room
- The opener for the exterior overhead door is not located in the room, and the interior door to get to the opener does not have a proper vestibule.

Figure 4-38: Ice Plant Room Louvre Mounting

- Seal the gap around the wall-mounted louvre and properly sleeve pipe penetrations.

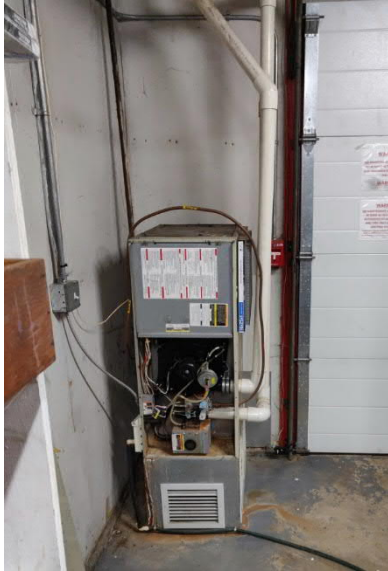
Figure 4-39: Ice Plant Room Furnace

Following the architectural recommendation to replace the ice plant with a new structure located outside the building, it is recommended to convert the room to unoccupied cold storage.

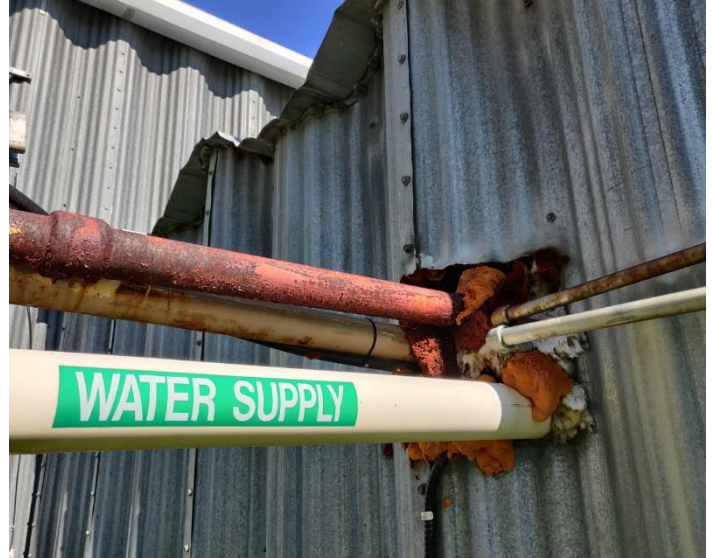
Figure 4-40: Ice Plant Room Pipe Penetrations

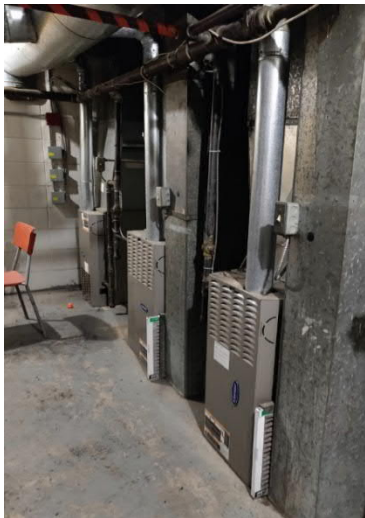
Minor corrosion is present on the galvanized steel exhaust flue ductwork for the Mechanical Room. AE recommends replacing the furnaces as they are past their expected lifespan of 18 years.

**Figure 4-41: Furnaces Ventilating Building Areas**

- Complete a ventilation study to determine how to meet ASHRAE 62 outdoor air rates for the building.
- Replacement of the three furnaces in the Mechanical Room.
- Provide heat to the stairwell and unheated service rooms.
- Repair damaged and disconnected sections of ductwork in the Locker Room areas.
- Replace all rusted or damaged ventilation grilles.
- Clean furnace ductwork throughout building.

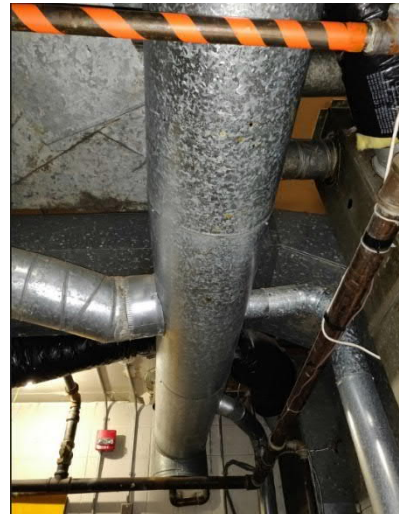
**Figure 4-42: Combination Flue for Mechanical Room Equipment**

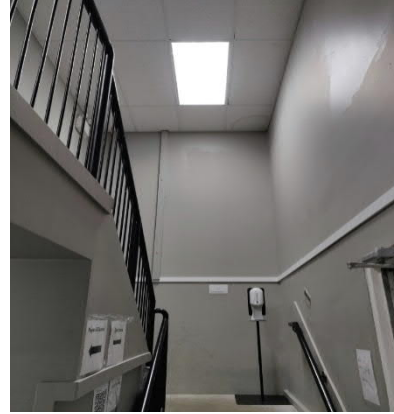
Figure 4-44: Ceiling Watermark in Stairwell

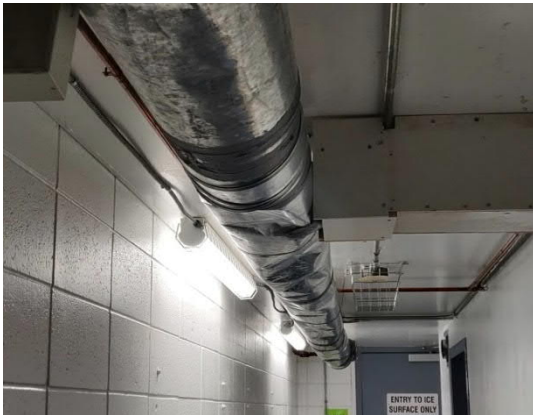
Distribution ductwork for the furnace systems consists of a mix of aboveground and buried ductwork, none of which appears to be insulated. The aboveground ductwork is painted in areas exposed to moisture, such as the shower areas. Ductwork that is not painted is corroded in some areas. Return ductwork that is exposed in the change room corridor is damaged due to repeated impacts. The return duct from the janitor room is disconnected and left open-ended.

Figure 4-45: Damaged Ductwork in Locker Area Corridor & Disconnected Duct to Referee Room

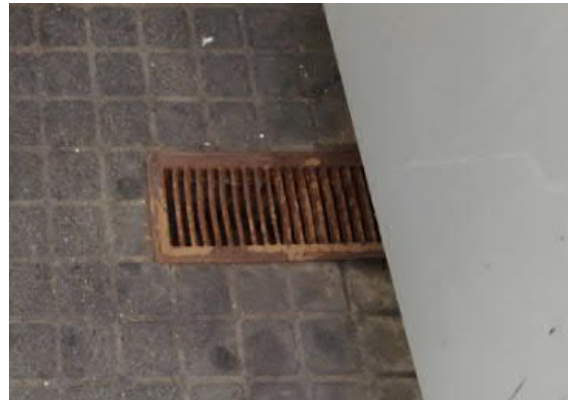
The ventilation grilles in the change room areas are nearly all showing extensive corrosion and should be replaced. Some grilles are missing entirely. Transfer air grilles in the Locker Room area are showing impact damage. Grille locations currently do not allow for optimal air mixing within the building.

Figure 4-46: Typical Corroded Supply Grille in Locker Area Shower Room

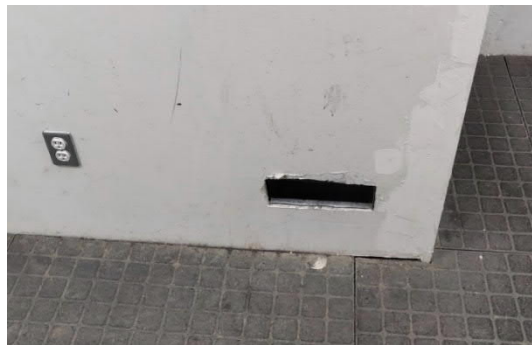
Figure 4-47: Typical Missing Ventilation Grille

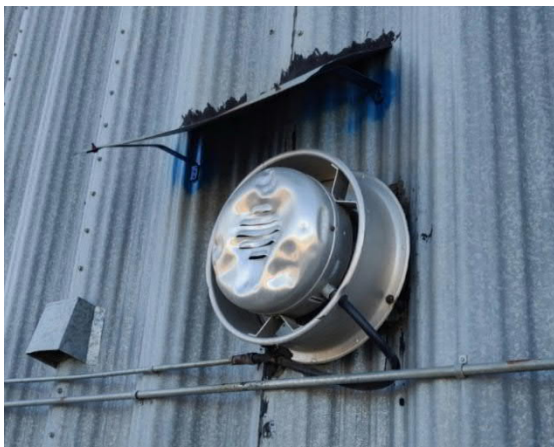
working order. The exhaust fan is showing signs of damage from falling snow and a flashing has been recently installed on the side of the building to protect the fan. The fan appears to be approximately 5 years remaining in its expected lifespan.

Figure 4-48: Locker Room Area Exhaust Fan

- Replacement of the exhaust fan in approximately 5 years.
- Clean dirty exhaust grilles and ductwork.

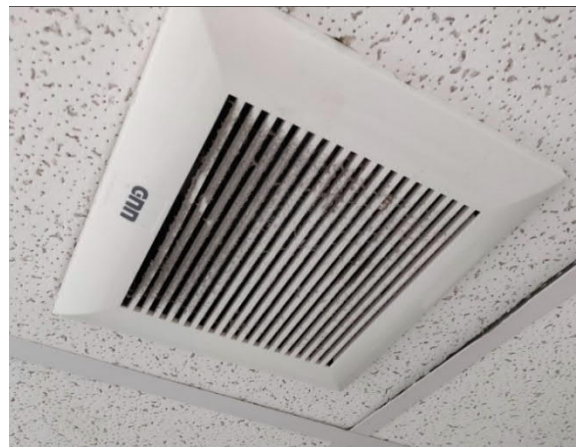
The exhaust air intakes on the Main Floor have accumulated dust which is clearly visible on the grille. Given the age of the ductwork, it is recommended to clean the ducts throughout the building to remove accumulated dust and debris within the ductwork. The washroom on the 2<sup>nd</sup> Floor has been recently renovated and does not show the same dust accumulation as the Main Floor grilles.

Figure 4-49: Typical Dust Buildup on Main Floor Exhaust Grilles

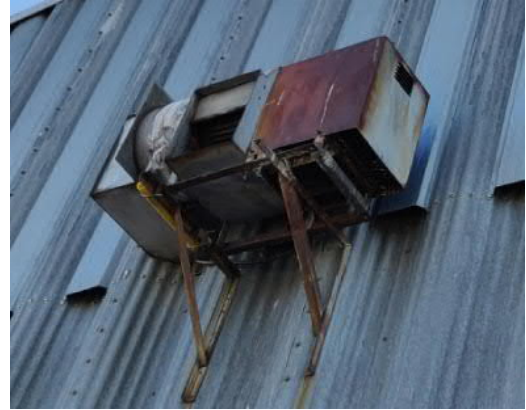
The kitchen has a commercial hood over the deep fryer that appears to be in relatively good condition. A switch beside the hood activates a belt-driven exhaust fan mounted on the outside of the building on the southwest wall. Although the fan does operate, it is visibly corroded and appears to be well beyond its expected lifespan. The kitchen does not have a make-up-air unit installed, so activation of the kitchen exhaust fan is assumed to draw air into the kitchen from other areas of the building. AE recommends installing a new make-up-air unit when the exhaust fan is replaced to prevent pressurization problems within the building when the hood is in use by supplying air to the kitchen.

Figure 4-51: Kitchen Hood Exhaust Fan

- Replacement of the kitchen exhaust fan.
- Provide make-up air to the kitchen hood.

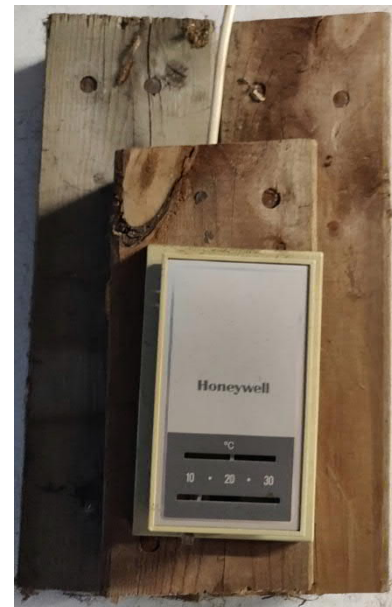
The building does not have a central control system and makes use of individual thermostats to control heating equipment and manual switches to control fans. The typical thermostat within the building is approximately 20 years old and is digital, but non-programmable, and does not have night set-back capability. AE recommends replacing thermostats with new programmable thermostats to ensure accuracy and to allow for night setback for minor energy savings.

Figure 4-53: Typical Thermostat for Heating Equipment

- Replace thermostats with programmable thermostats.

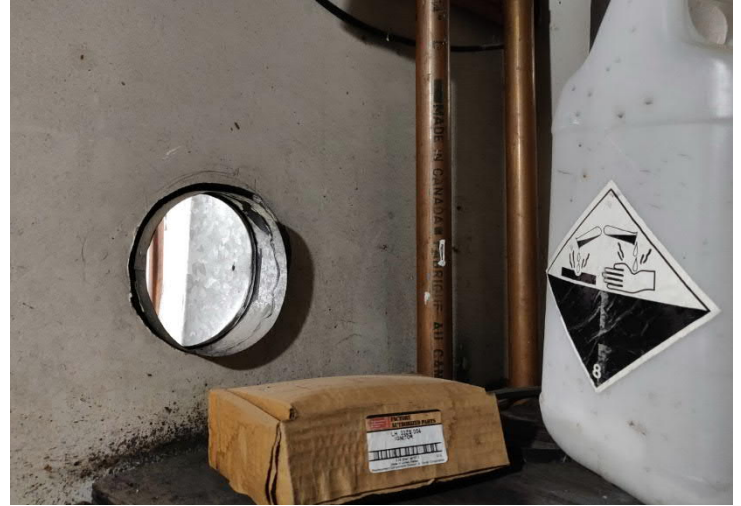
**Figure 4-57: Opening in Mechanical Room Wall Without Fire Damper**

- Install fire dampers within dampers and fire caulking around pipes that penetrate fire rated walls.

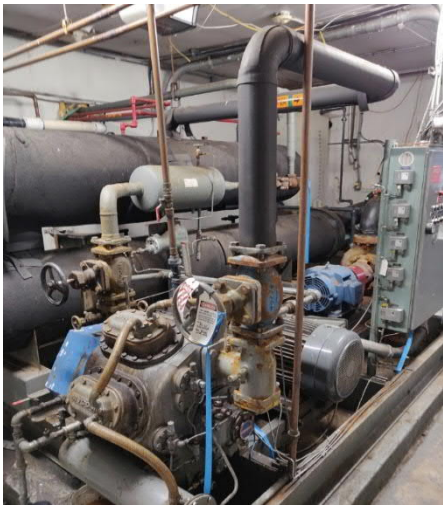
The main reciprocating compressor is original to the plant and is currently leaking oil and a bucket is placed beneath it to catch drips. Extensive corrosion is visible on piping and components carrying both ammonia and brine.

Figure 4-58: Ice Plant Skid

- Complete replacement of the ice plant including the ammonia plant skid, condensing unit, and brine system components. Recommended location of the new ice plant is in a separate enclosure outside the building (refer to architectural recommendations).
- Replacement of the in-slab tubing. (Refer to architectural section for recommendation to replace the arena slab).

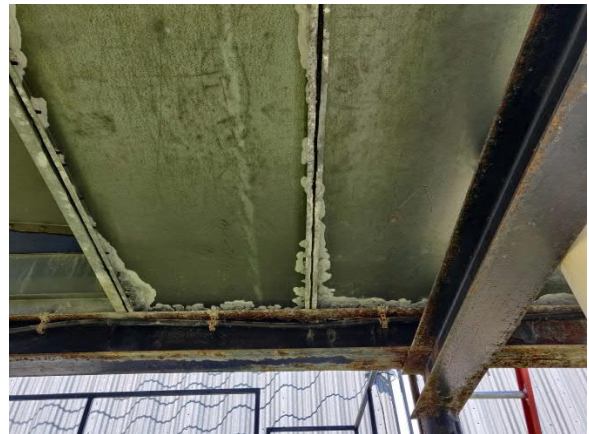
Figure 4-61: Underside of Outdoor Condensing Unit

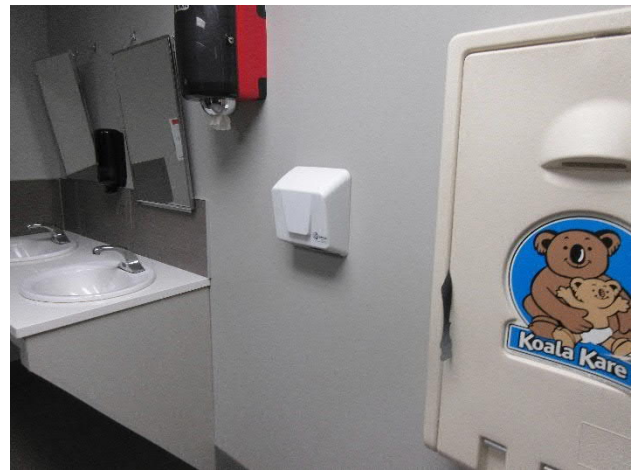
Figure 5-8: Washroom; No Receptacles

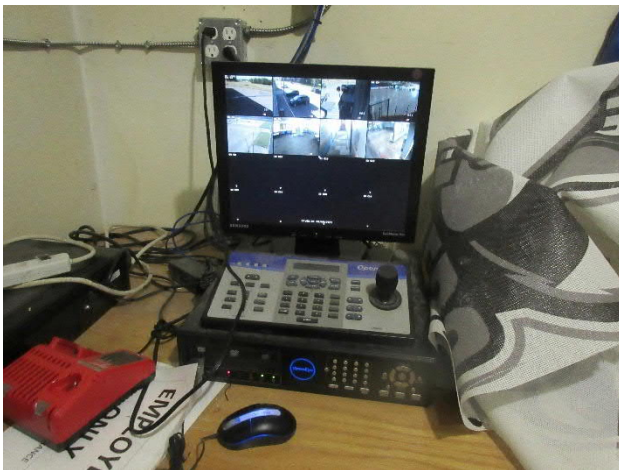
A CCTV security camera system is installed in the facility with a total of 8 cameras installed throughout. the cameras are connected to the main CCTV control station located in the Electrical Room. The CCTV system is 20 years old. AE recommends replacement in the next 1-3 years.

Figure 5-9: CCTV Security System

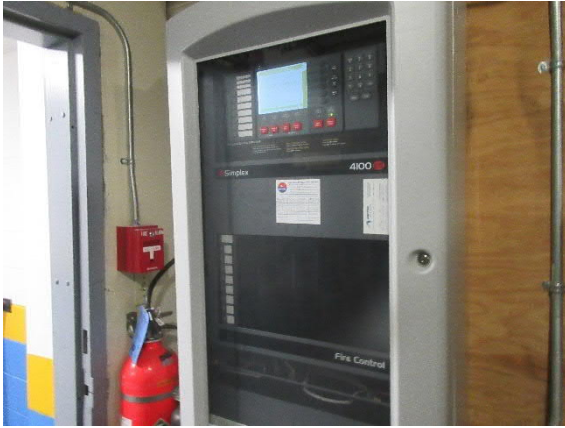
Figure 5-13: Main Fire Alarm Control Panel in Electrical Room

AE recommends fire alarm drawings be created for the building.

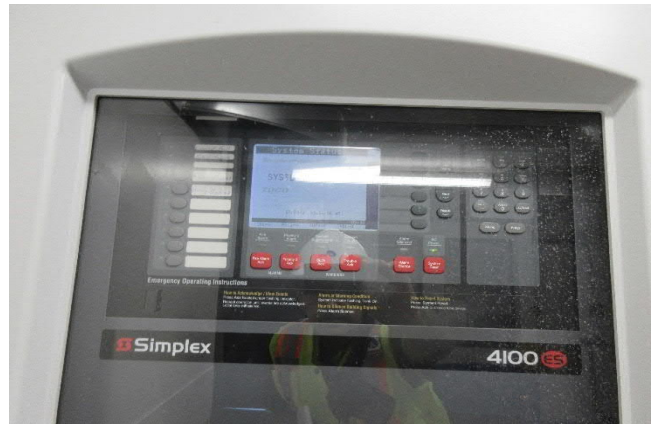
Figure 5-14: Main Fire Alarm Control Panel in Main Vestibule

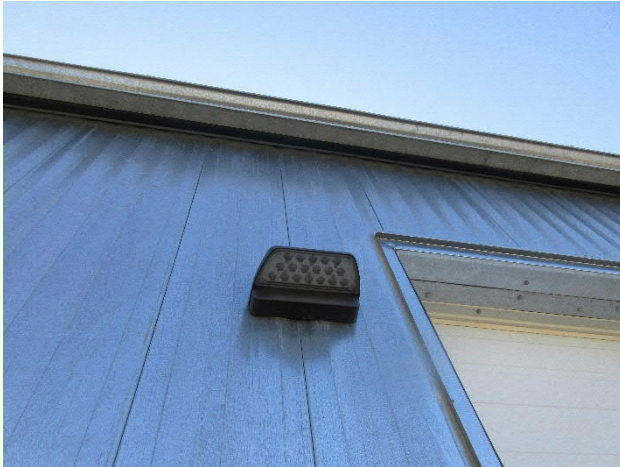
As the site was visited during the day, all exterior lights were off and unable to be confirmed if in working order. 3 of the wall packs were replaced 3 years ago with an LED fixture and 3 existing fixtures are HID. AE recommends replacement of the HID light fixtures with LED light fixtures for energy savings in the next life cycle replacement, within the next 2-5 years.

Figure 5-17: Typical LED Exterior Lighting

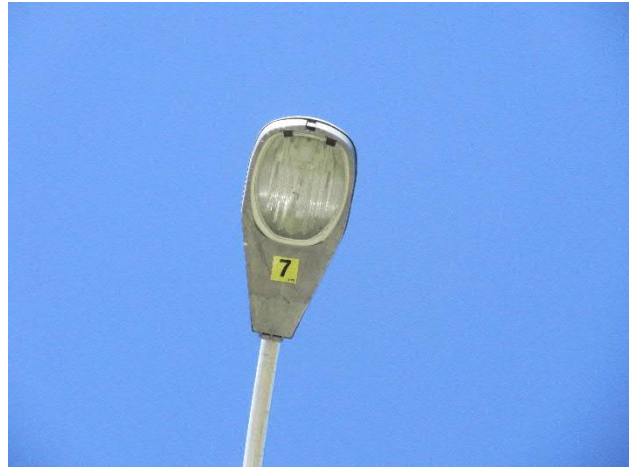
Two pole mounted lights at the main entrance south are LED, the other 5 pole mounted lights are HID, all exterior fixtures have a built-in photocell. AE recommends replacement of the HID lights with LED lights for energy savings in the next life cycle replacement within the next 2-5 years.

Figure 5-18: Typical HID Lighting Standard

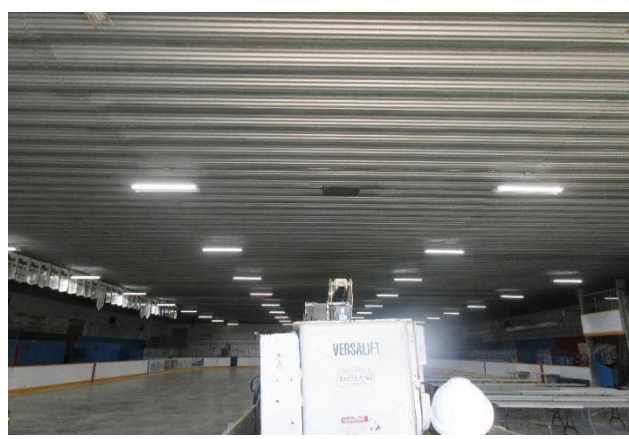
Luminaires in Dressing Rooms have polycarbonate lens and are rated for a damp environment. Luminaires in arena rink were replaced 3 years ago with linear LED without mechanical protection. AE recommends installing protective guards immediately.

Figure 5-20: Arena Lighting

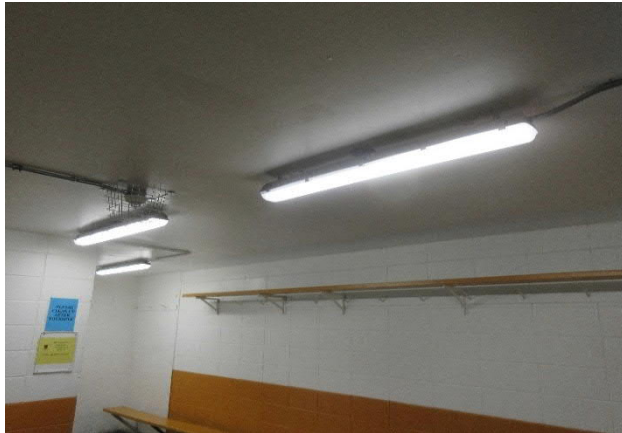
Figure 5-21: Dressing Room Lighting

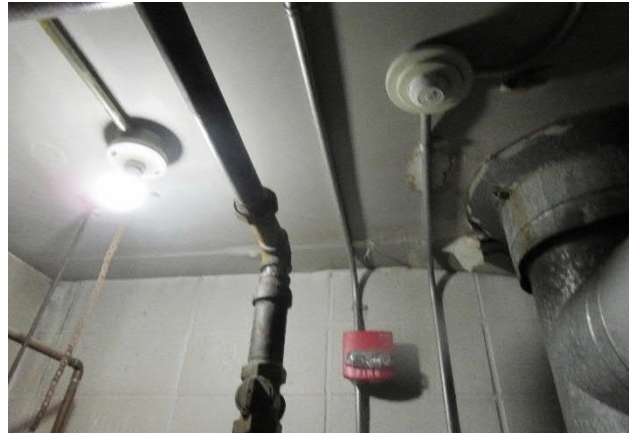
Lighting in service rooms are A19 bulb screw type with no protective guards, they are prone to mechanical damage. AE recommends immediately installing protective guards or replace fixtures with linear luminaire with polycarbonate lenses.

Figure 5-22: Room Lighting

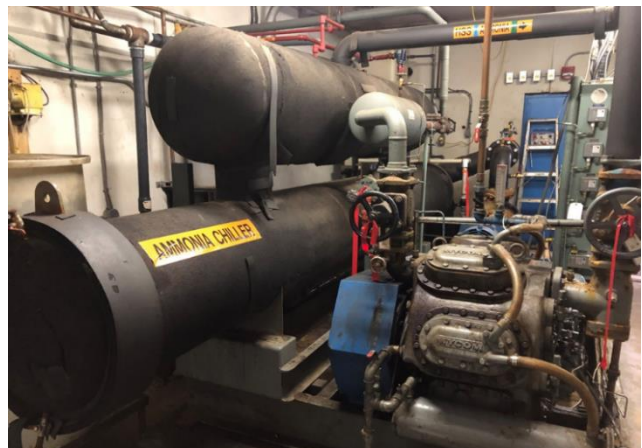
**Figure 2 - Ice Making Equipment**

The ice plant requires significant maintenance and is considered past the end of its rated life. An inventory of the facility's process equipment can be found in [Table 4](#).

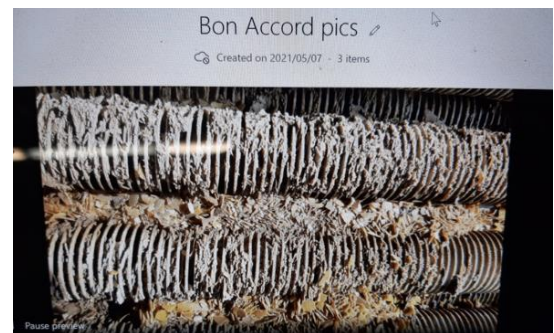
The existing condenser is in poor condition causing a reduction in system efficiency. An adiabatic condenser has been selected over the existing evaporative style which will add additional savings from water consumption. The overall system efficiency of the existing system is reduced due to the condition of the evaporative cooler.

Figure 11 - Existing Condenser
